ILLINI WEST HIGH SCHOOL DISTRICT #307
PHASE ONE: INITIAL ASSESSMENT SUMMARY REPORT

RE: Phase One - Step One - Initial Assessment Summary Report

EXISTING HIGH SCHOOL BUILDING CONDITION REPORT

Site Survey Date: May 24, 2019

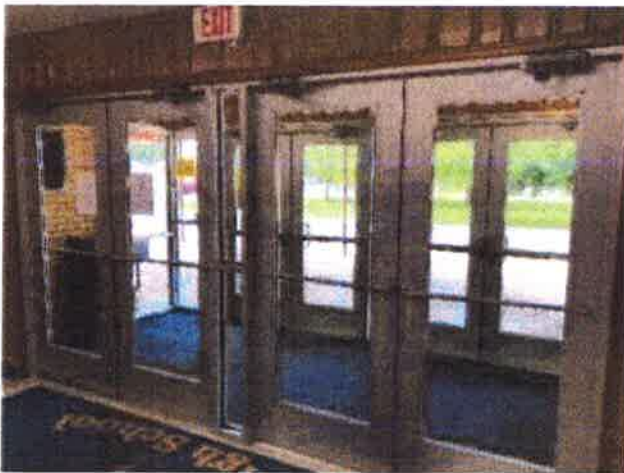
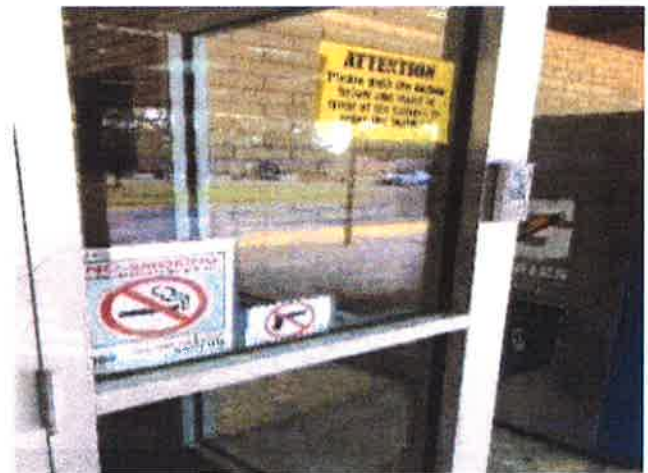
1. MAIN ENTRANCE TO BUILDING

The main entrance currently has an exterior intercom with camera monitored by the school administration office. There is a controlled lock whereby the administration office can open to allow entrance into the building. There is also an interior set of doors as a vestibule with no interior locking hardware. Once someone is inside the vestibule, there is no containment measure via locks on the interior door set. The door systems are in moderate working condition however, will require some modification for a higher security controlled operation.

1. Upgrade Entrance/Exit Doors and Electronic Control Hardware Throughout Building
2. Install and Upgrade Security Camera System and Head End Controls

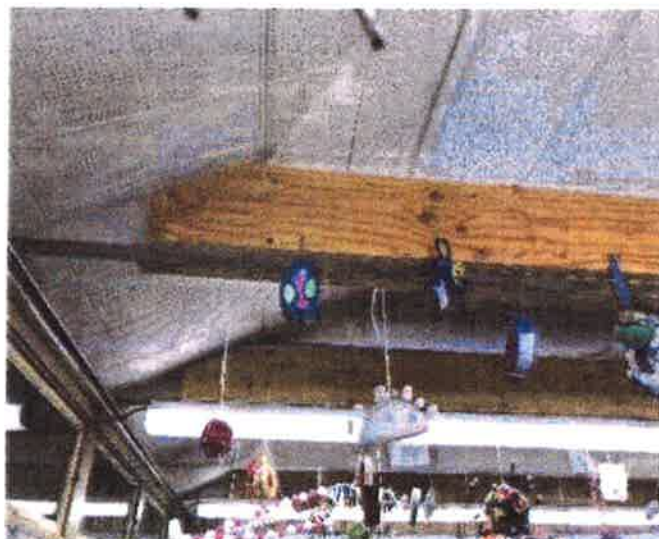
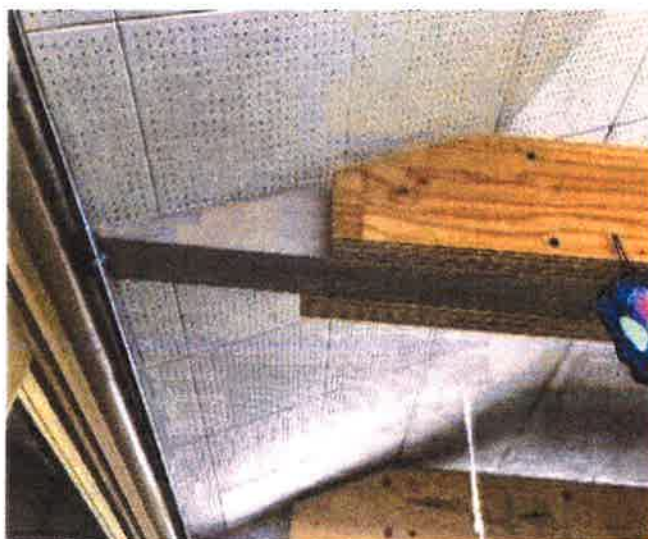
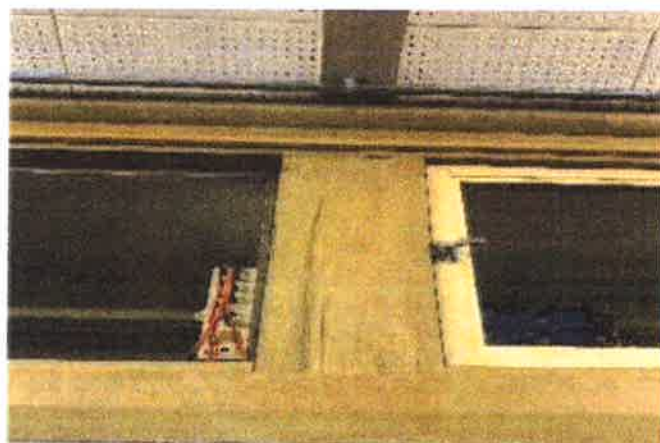
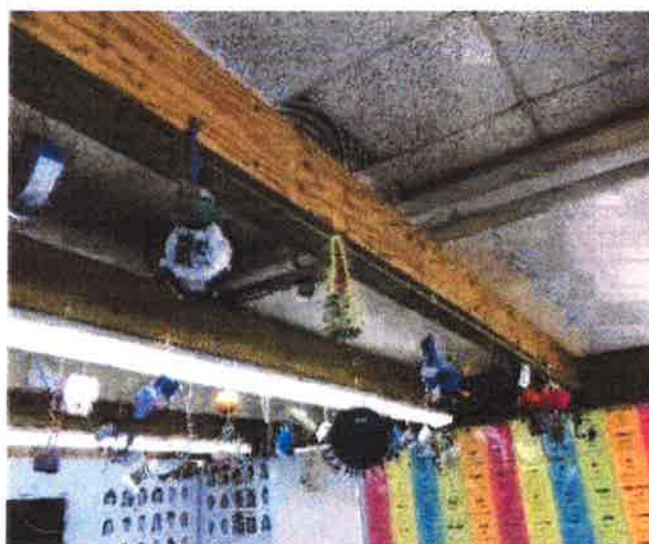
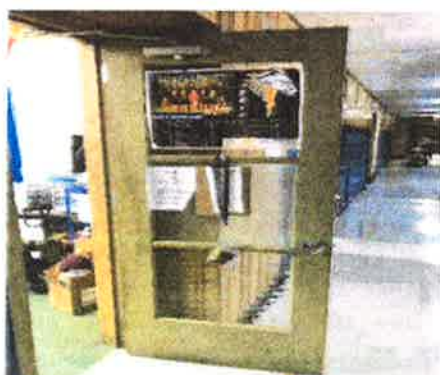
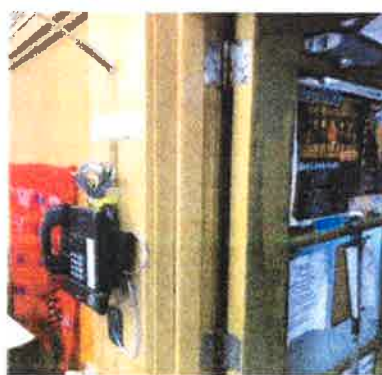
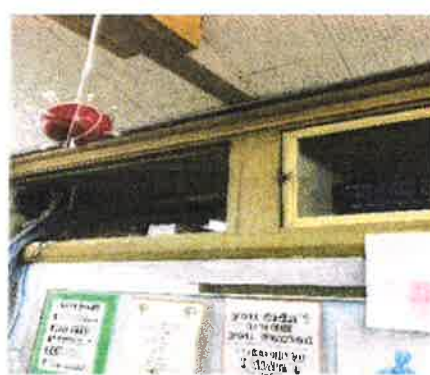
2. WEST WING CLASSROOMS

Within the majority of the west wing classrooms, there are laminated wood beams that have been fastened to the original existing wood ceiling roof joists on each side. As evident in the attached photos, the attached laminated beams do not extend to any of the wall bearing points of the original joists. These were added due to cracking and deflecting of the original joists from roof load weight over a period of time. Full replacement may be warranted. We recommend a study from structural engineer. Replacement would require removal and replacement of roof system in the areas affected by structural work.

The original joists appear to bear on posts that are part of an interior corridor wall with wood frame single pane clerestory windows to the corridor. The classroom doors and frames are also wood with single pane window lights.

The corridor to classroom walls and doors are not of a fire rated construction system. There is a substantial amount of non-fire rated wood paneling in the corridor and classrooms that are combustible material by nature. There is an active fire alarm system in the building, however there is no fire sprinkler suppression system in the building.

1. Remove Existing Roof Structure and Ceiling/Roof Joists.....
2. Remove Corridor Walls and Open Floor for New Footings.....
3. Install New Corridor Wall Footings, Bearing Structure for Roof Joists.....
4. Install New Roof Joist, Deck, Roofing System and Edge Metals.....
5. Renovation to Meet Code Compliance.....
6. New Finishes for All Renovation (Including Finishes From Asbestos Removal)

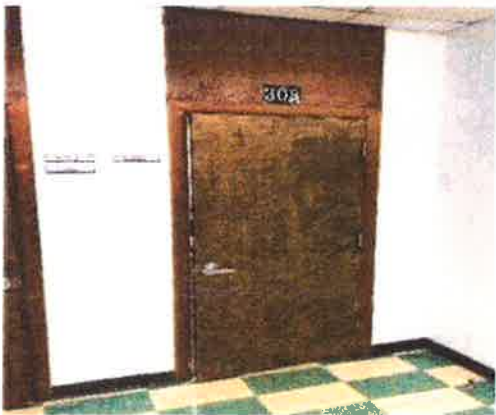
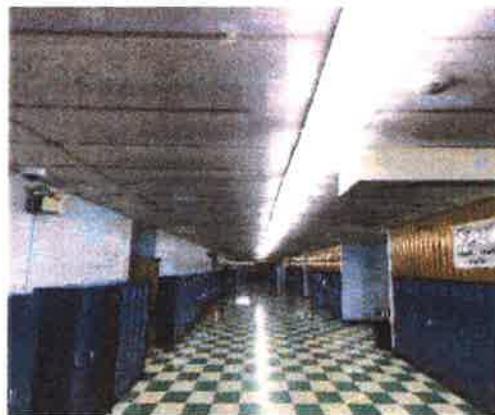
3. EAST WING CLASSROOMS

Similar to the West Wing Classrooms, all classroom entrances in the East Wing have wood doors and frames at the room point of entry. Additionally, there is wood material transoms above the door which in closer viewing have no designated labeling as a fire rated system, hence non-rated separation to the classroom at the door openings. The wood material present in the corridor as shown is considered combustible as it is not fire rated material. Inside, the interior of the classrooms have more current acoustical grid ceilings and are of different construction make up in comparison to the West Classrooms. Further investigation is recommended above ceiling and assessing electrical system in this area. There is a fire alarm system in place, however, there is no fire sprinkler suppression system.

1. Remove and Replace All Existing Door Systems to Fire Rated Systems
2. Renovation to Meet Code Compliance
3. New Finishes for All Renovation (Including Finishes From Asbestos Removal)

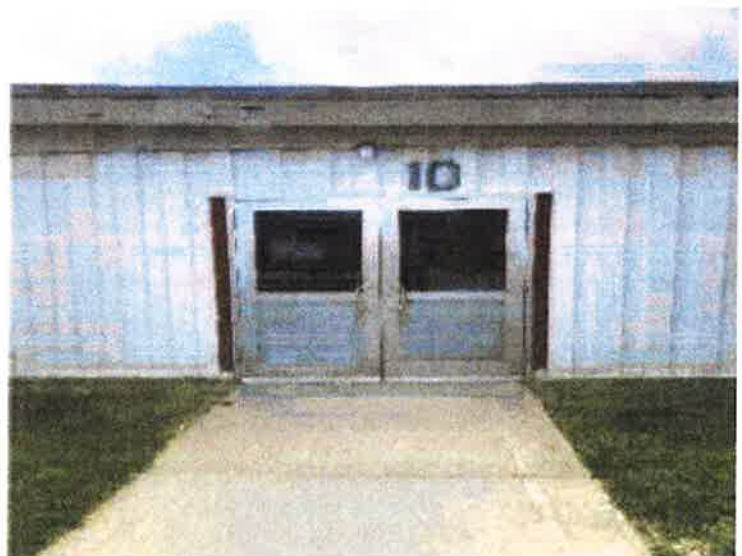
4. EAST WING CORRIDOR EXIT TO NORTH PORTABLE CLASSROOMS

The existing aluminum storefront entrance door system is left unlocked during school hours for students to access the main building from the west portable classrooms. There is manual locking hardware in place on the doors, however, the entry system lacks electronic activated hardware provisions to lock down the entrance doors in the event of an emergency via a remote location such as the administrative office.

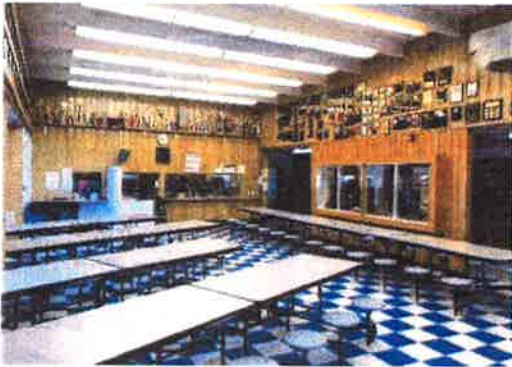
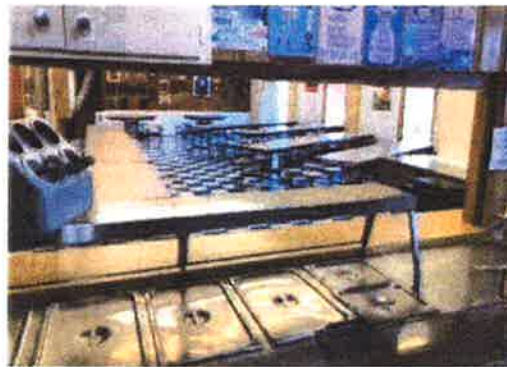
5. CAFETERIA

On the west exterior wall of the cafeteria there are two sets of aluminum storefront exit doors to the outside. These door sets are left unlocked during the school day for students to access the main building from the west portable classrooms. There is manual locking hardware in place on the door sets, however, the entry system lacks electronic activated hardware provisions to lock down the entrance doors in the event of an emergency via a remote location such as the administrative office. There also exists exposed wood paneling that is considered combustible and a non-rated separation wall system between the cafeteria and corridor. There are no door systems into the corridor between the cafeteria and the corridor at the circulation openings. There is a fire alarm system in place, however, there is no fire sprinkler suppression system.

1. Replace Wood Paneling With Fire Rated Gypsum Wallboard
2. Install Door Systems to Corridor at Current Openings
3. Provide ADA Accessible Means to Office and Storage
4. New Finishes for All Renovation (Including Finishes From Asbestos Removal)

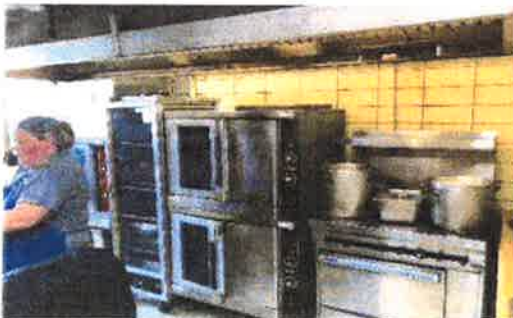
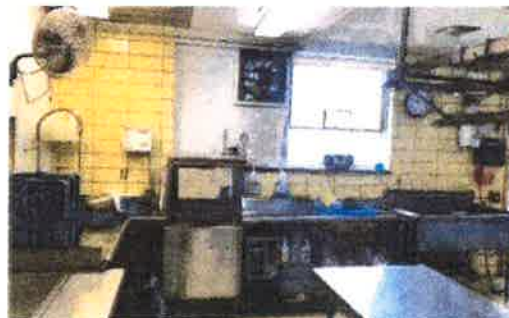
6. PREPARATION AND SERVING KITCHEN

The existing kitchen serves the main high school population, special education students and also provides meal service for a portion of the separate elementary school district in the adjacent building. Equipment, exhaust hood and hood fire suppression system are antiquated and can be assumed to be at the end of their useful life.

1. Remove Existing Fixed Kitchen Systems
2. Install Current Code Rated Hood, Make Up Air and Fire Suppression
3. Replace Existing Kitchen Equipment
4. New Finishes for All Renovation (Including Finishes From Asbestos Removal)

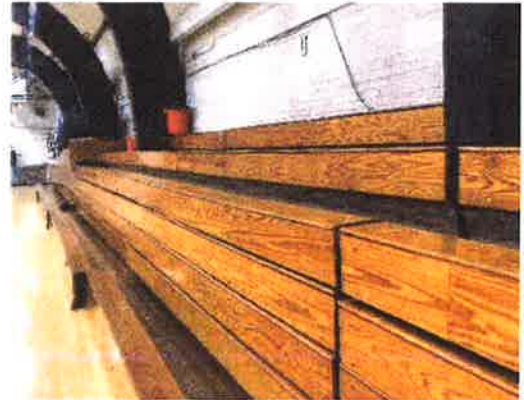
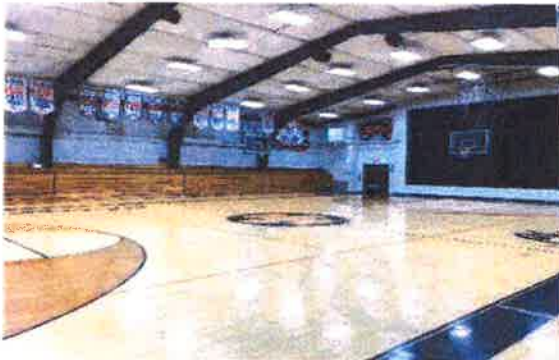
7. GYMNASIUM

Within the gymnasium there are manually opening wood bleachers that are antiquated and can be assumed to be at the end of their useful life. Slide hardware mechanisms display significant wear and potentially could be a safety concern for staff attempting to open them for use on a regular basis. There are wood entrance doors that go into the gymnasium from the corridor with no securing hardware. While there are closers present on the doors there are no visible fire rating tags and the doors have significant sag and binding and do not close completely. Similar conditions exist with lack of fire separation at the doors an upper wood wall sections. There is a fire alarm system in place but no fire suppression system.

1. Replace Bleachers With Code Compliant System
2. Replace Door Systems With Fire Rated Assemblies
3. New Finishes for All Renovation (Including Finishes From Asbestos Removal)

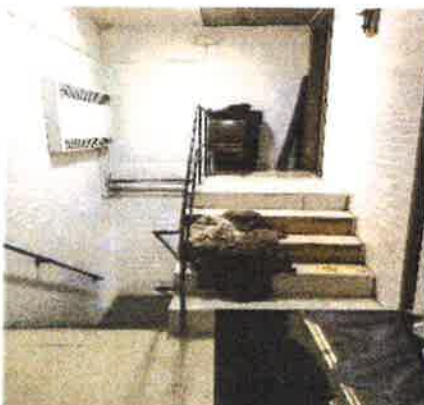
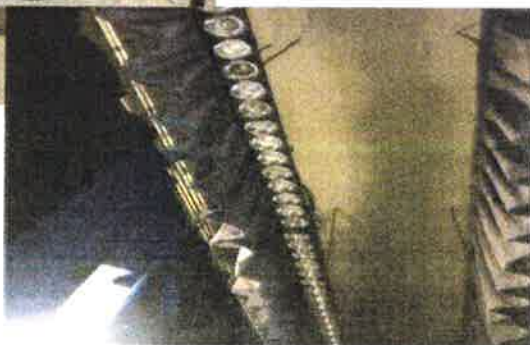
8. STAGE AREA

There currently is no ADA accessible access to the main stage floor from the gymnasium level floor. There are existing stairs that has a single pipe railing that is not compliant with current code and is unsafe. The stage curtain system is outdated and likely does not meet current flame spread requirements. The overhead fixed stage lighting is also antiquated and appears to be past its useful life. There is not an active rigging system where the light bar could be lowered to change bulbs or fixtures in a safe manner. As in many other areas of the building there are exposed wood elements that are not of a fire rated material. There is a fire alarm system in place, however, there is no fire sprinkler suppression system.

1. Install ADA Accessible Means to Stage Floor Level
2. Remove and Replace Stage Lighting and Install Rigging System
3. Remove and Replace Stage Proscenium Opening Curtains
4. Remove Exposed Non-Fire Rated Wood, Replace With Fire Rated Gypsum Board Assembly
5. New Finishes for All Renovation (Including Finishes From Asbestos Removal)

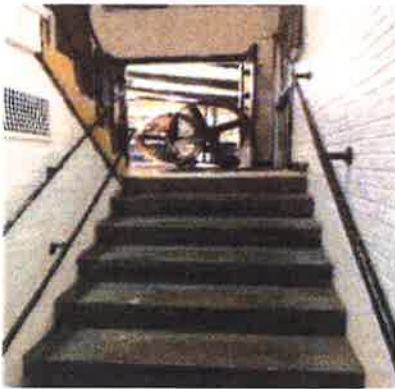
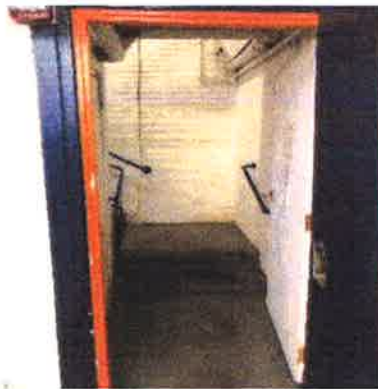
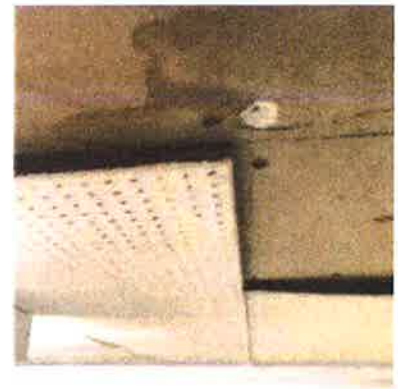
9. LOCKER ROOMS (LOWER LEVEL)

There currently is no ADA accessible access to the existing locker rooms area. The only means of access to the locker rooms is by stairs to the lower level with a non-compliant current code railing system. There is also only one means of egress to exit this space which raises safety concerns not only with egress but also from a supervisory standpoint as well. There is a fire alarm system in place, however, there is no fire sprinkler suppression system. Plumbing and electrical components in this area are antiquated and are assumed to be past their useful life.

1. Install ADA Accessible Means to Lower Level Locker Room
2. Install a Second Means of Egress From Locker Room
3. New Finishes for All Renovation (Including Finishes From Asbestos Removal)

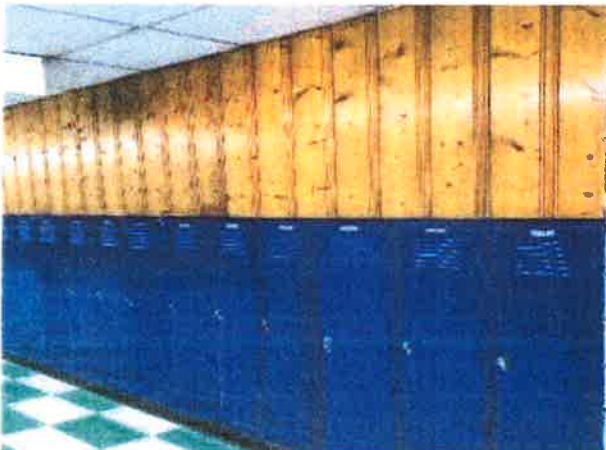
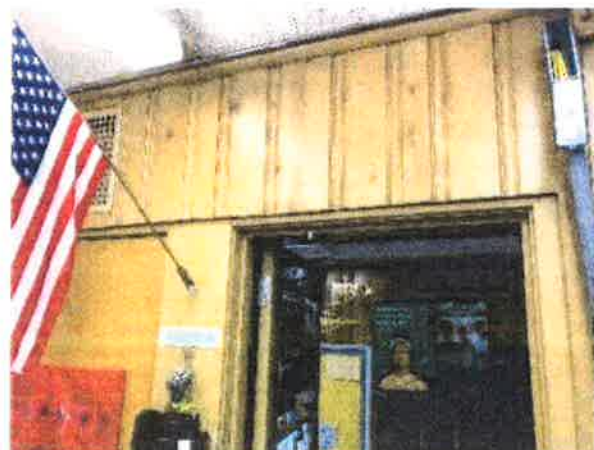
10. MAIN CORRIDOR AND SOUTHWEST WING

The wall components in the main corridor and south west wing consist of masonry with a substantial amount of wood paneling, wood clerestory windows and wood entrance door and frame systems. Primarily the wood components are not of a fire rated assembly to provide fire separation between spaces adjacent to the corridors and considered combustible. There is a fire alarm system in place, however there is no fire sprinkler suppression system.

1. Remove Exposed Wood Paneling and Replace with Fire Rated System
2. Remove Wood Window Door System and Replace With Fire Rated Systems
3. Make any Needed Structural Repairs and Reinforcements Needed
4. New Finishes for All Renovation (Including Finishes From Asbestos Removal)

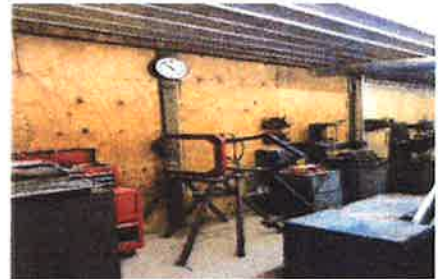
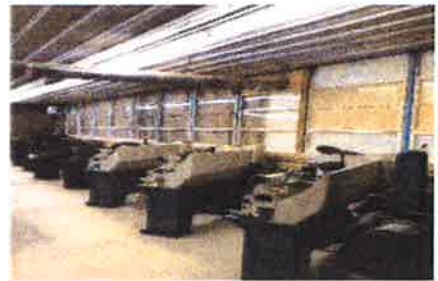
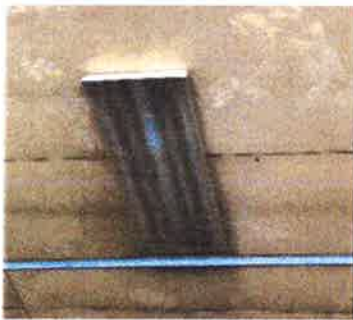
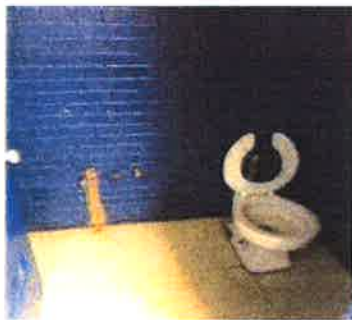
11. TECH SHOP AREAS

There is a wall separating the wood working and welding shop areas with a service door. There is no visible fire rated labeling on the door and frame assembly. There is an extensive amount of transite panel on the ceilings and walls in this area and is listed in the asbestos inventory report. There is a separation wall between the machine shop and the wood working area consisting of wood frame and single pane glass panels with various materials attached to it. This is not a fire rated assembly in a separation wall. There is also exposed exterior siding sheathing on the exterior wall of the machine shop space. All of the exposed wood material is non-fire rated and considered combustible. This area also has a single restroom with only a stool and no sink which does not meet current code requirements.

1. Replace Wall and Ceiling Surfaces Throughout With Fire Rated Gypsum Assembly
2. Remove and Replace Wall Between Wood Shop and Machine With Fire Rated System
3. Complete Renovation of Single Room Toilet to Code Compliant
4. Replace Aged Collection Systems with New Code Compliant
5. New Finishes for All Renovation (Including Finishes From Asbestos Removal)

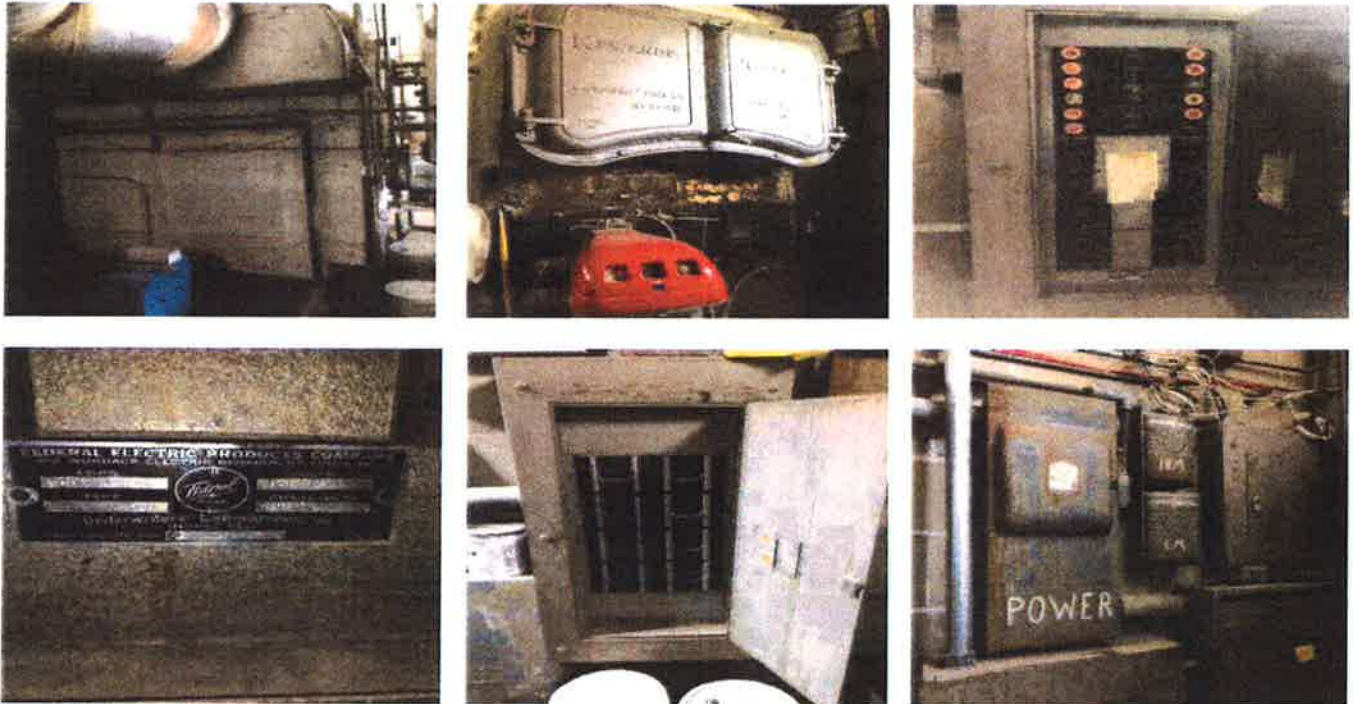
12. BOILER ROOM

The main existing boiler is an old Kewanee boiler with assumed asbestos wrapping. The boiler has received a burner upgrade, however, the entire system of the boiler and the piping is assumed to be past its useful life and continue to require ongoing extensive maintenance. Additionally, the operational efficiency is low in performance and results in higher energy cost usage for the school along with limited ability to accommodate comfort issues in spaces within the building. Typically with piping this age it is found to be deteriorating especially if there has not been a chemical feed system to treat the system water. Domestic water piping also appears to be original and assumed to be in the same deteriorating condition. In general the entire building HVAC / Mechanical system would be recommended to be replaced in its entirety. Additional note that a good amount of the visible piping lacks required insulation.

The electrical main service panels are assumed past their useful life and in a state of deterioration. Some sub panels have antiquated fuse blocks and screw in fuses which do not have provisions for ground fault interruption protection. Some of the panels were manufactured by the Federal brand which is no longer in business and also have a history of defective components. It would be recommended to completely replace the electrical service and entire building system. Distribution wiring is antiquated and can be assumed to be at the end of its useful life.

1. Complete Removal, Upgrade and Installation of Mechanical HVAC System Throughout
2. Complete Removal, Upgrade and Installation of Electrical and Lighting System Throughout
3. Complete Removal, Upgrade and Installation of Domestic Water and Needed Sanitary Systems
4. Upgrade Water Service Into Building to Accommodate Fire Sprinkler Suppression System
5. Upgrade Both Gas and Electrical Services Into Building to Accommodate New Systems
6. Install New Code Compliant Fire Sprinkler Suppression System Throughout
7. New Finishes for All Renovation (Including Finishes From Asbestos Removal)

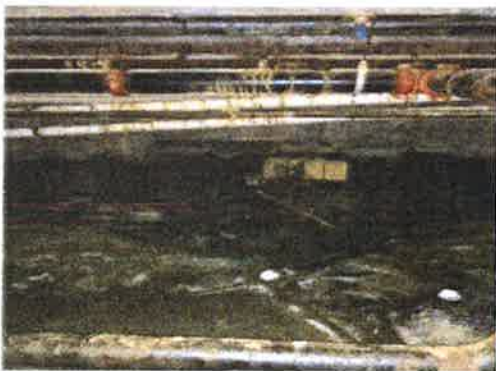
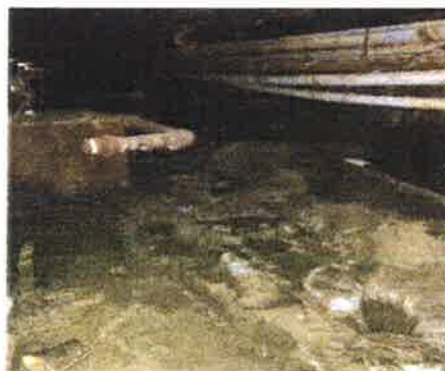
13. BUILDING TUNNEL SYSTEM

The service tunnels under the building contain the distribution piping for domestic water service and boiler hot water piping. There are dirt floors and no permanent moisture control measures in place. The condition at time of observation was wet and presented a musty odor when inside the space. Again due to the age of the building it is likely that some of the piping insulation may contain asbestos. What was visible at the time of observation appeared to be in deteriorating condition. Minimum recommendations would be to place a moisture barrier and a material such as flowable fill to seal off the moisture migration into the tunnels. HVAC and Mechanical items referenced above.

1. Remove Debris in Tunnels, Dry and Level Subgrade Material
2. Install New Waterproof Barrier Material and New Sealed Concrete Floor
3. Install New Service Lighting in Tunnel
4. Install New Ventilation System in Tunnel
5. Install New Secure Entrance Door to Tunnel Opening

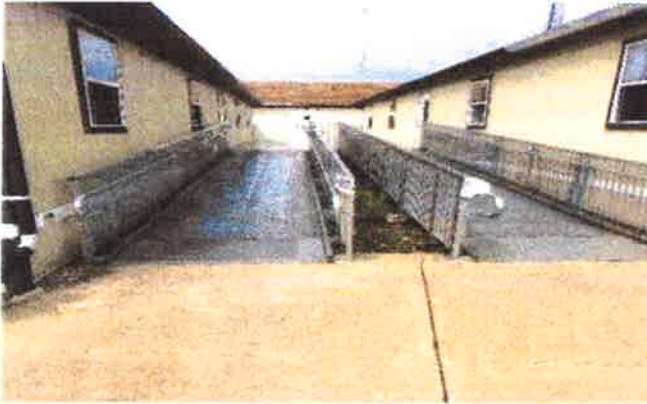
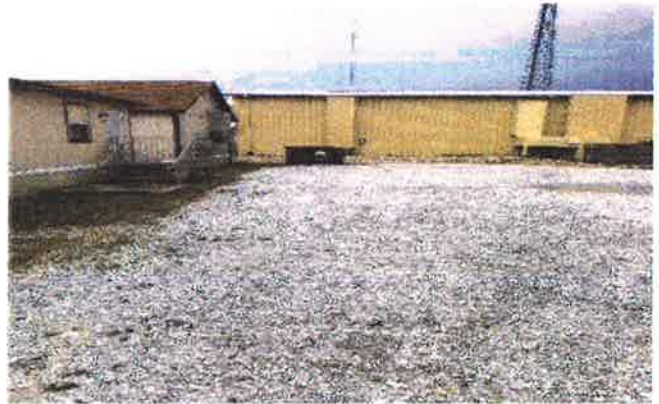
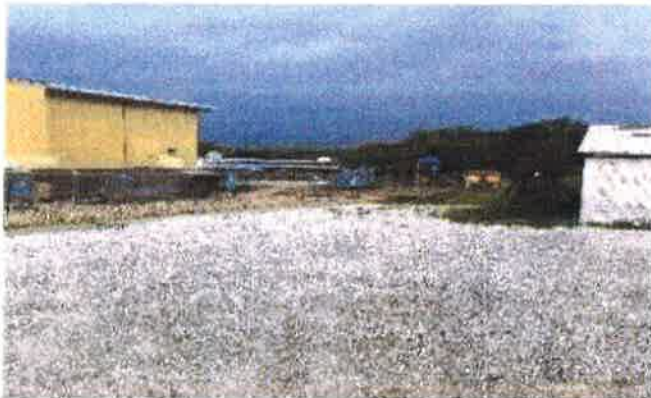
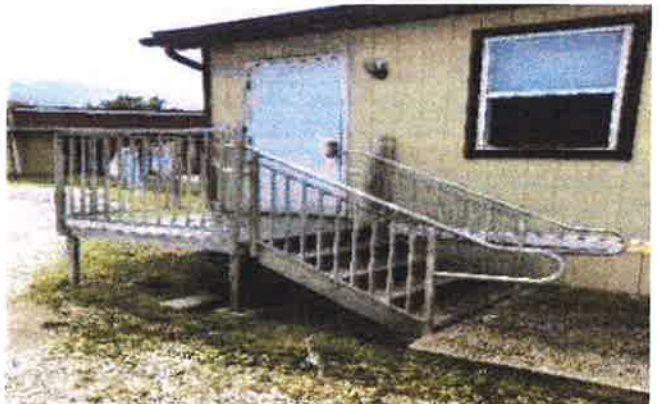
14. WEST TEMPORARY PORTABLE CLASSROOMS

The west portable classrooms are configured near the main building and are accessed through the west exterior doors in the cafeteria which are left open during school hours. There are no fencing or control barriers around the portable classrooms to deter a potential intruder. Additionally there are no security monitoring cameras in place to monitor activity around the portable classrooms. The ramps, stairs and decking are made of aluminum and input from maintenance staff and teaching staff relayed that the surfaces are a safety issue as there have been slippage issues for students during rainy or winter weather events. Overall a number of safety concerns upon observing this area.

1. Remove Portable Classrooms and Temporary Systems and Provisions
2. Construct a New Permanent Classroom Addition Connected to Main Building

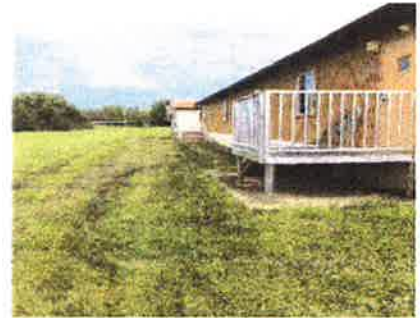
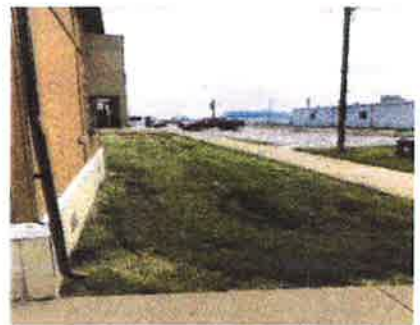
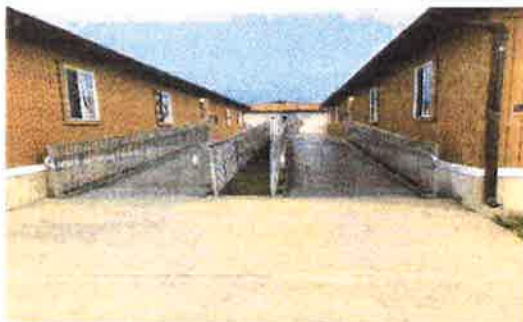
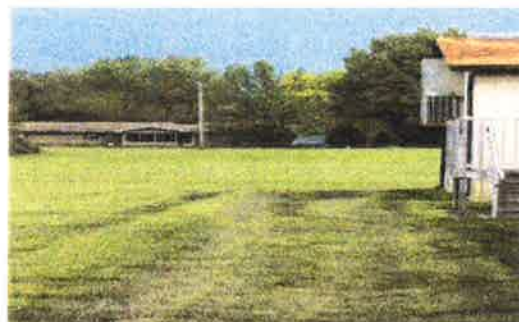
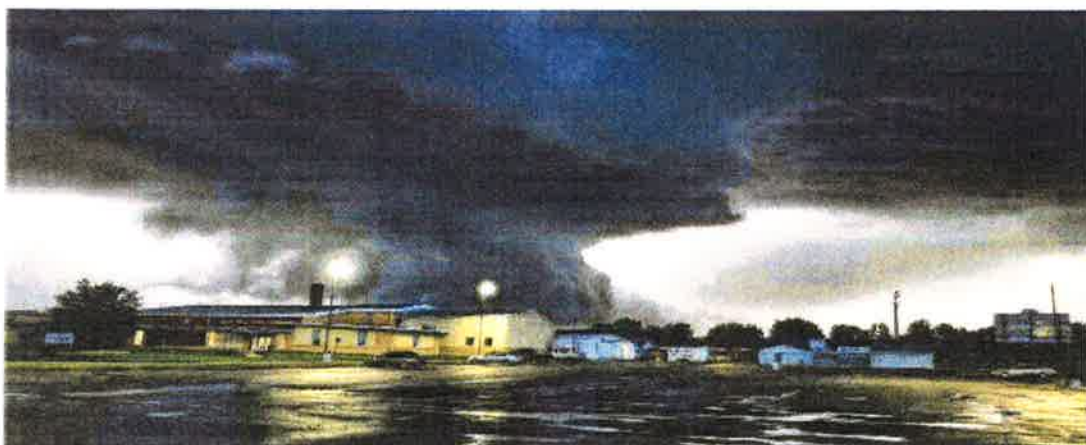
15. NORTH TEMPORARY PORTABLE CLASSROOMS

The north portable classrooms are configured further away from the main building than the west classrooms. This requires students using this set of portable classrooms to travel a longer distance from the main building east wing entrance doors. The ramps, stairs and decking are of the same aluminum material as the west units where both maintenance and teaching staff stated the surfaces are a safety concern in rainy or winter weather that has resulted in the students slipping on the surfaces. Also as with the west units, there are no fencing or control barriers in place around the portable classrooms to deter potential intruders. Residential properties are visible and back up to the green space behind the units and there is free access around the east end of the building to drive vehicles directly to the location of the portable classroom units. These units are further isolated from the main building with no security camera monitoring for supervision.

A general statement regarding both sets of portable classroom pods. The wind load rating of the tie downs that secure the units in place have limitations. From a safety perspective the portable units do not provide the protection and security of a permanently constructed building structure. It is required by code that in advance upon learning of an approaching severe weather event, the portable classrooms be evacuated and occupants take shelter within the main building in a secure area. The west portable classrooms have been in place for eleven years and the north portable classrooms have been in place for 10 years.

1. Remove Portable Classrooms and Temporary Systems and Provisions
2. Construct a New Permanent Classroom Addition Connected to Main Building

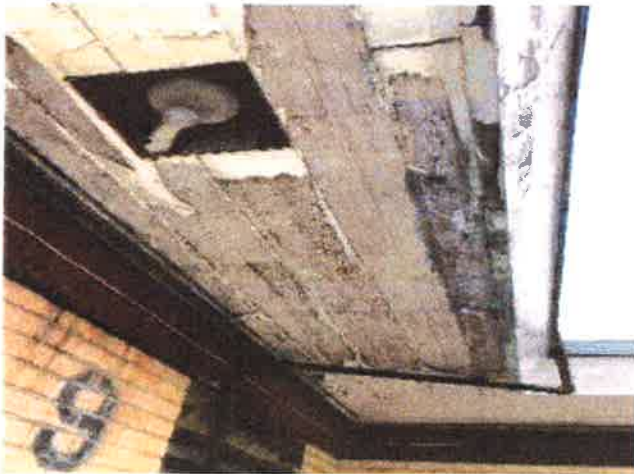
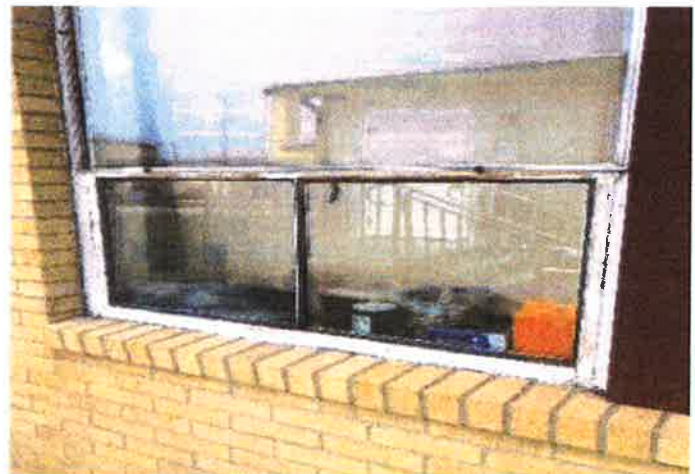
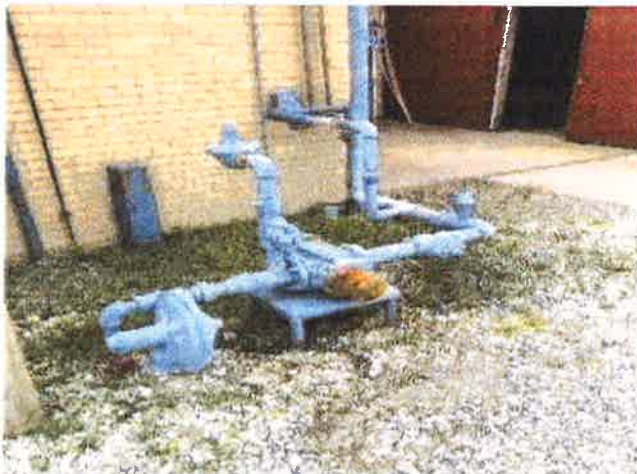
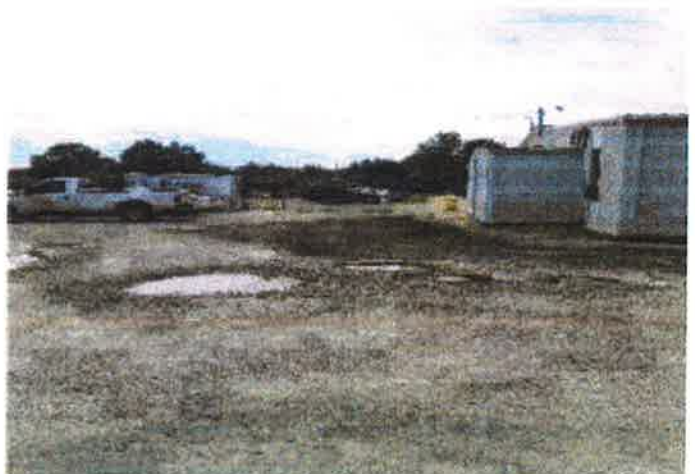
16. BUILDING EXTERIOR

The building exterior envelope is in need of maintenance including cleaning of the masonry, point tucking in a number of areas and sealing. Complete replacement of the wood soffit and fascia system with metal no-maintenance soffit and fascia system with rain gutter system to direct water away from building, replace windows though out as existing window systems are single pane glass with energy code compliant window system, replace original metal service doors and frames with new including security hardware system, replace and upgrade all utility services to the building to accommodate the new replacement systems projected to be installed. Assume that some repair and replacement of sidewalk and paving systems will be needed to meet ADA accessibility measures and maintenance needs.

1. Clean, Point Tuck and Seal Masonry Veneer
2. Remove and Replace Windows With Energy Code Compliant Systems
3. Remove and Replace Soffit and Facia System
4. Repair and Replacement of Paving Areas
5. Repair and Replacement of Sidewalks and Adjust for ADA Accessibility

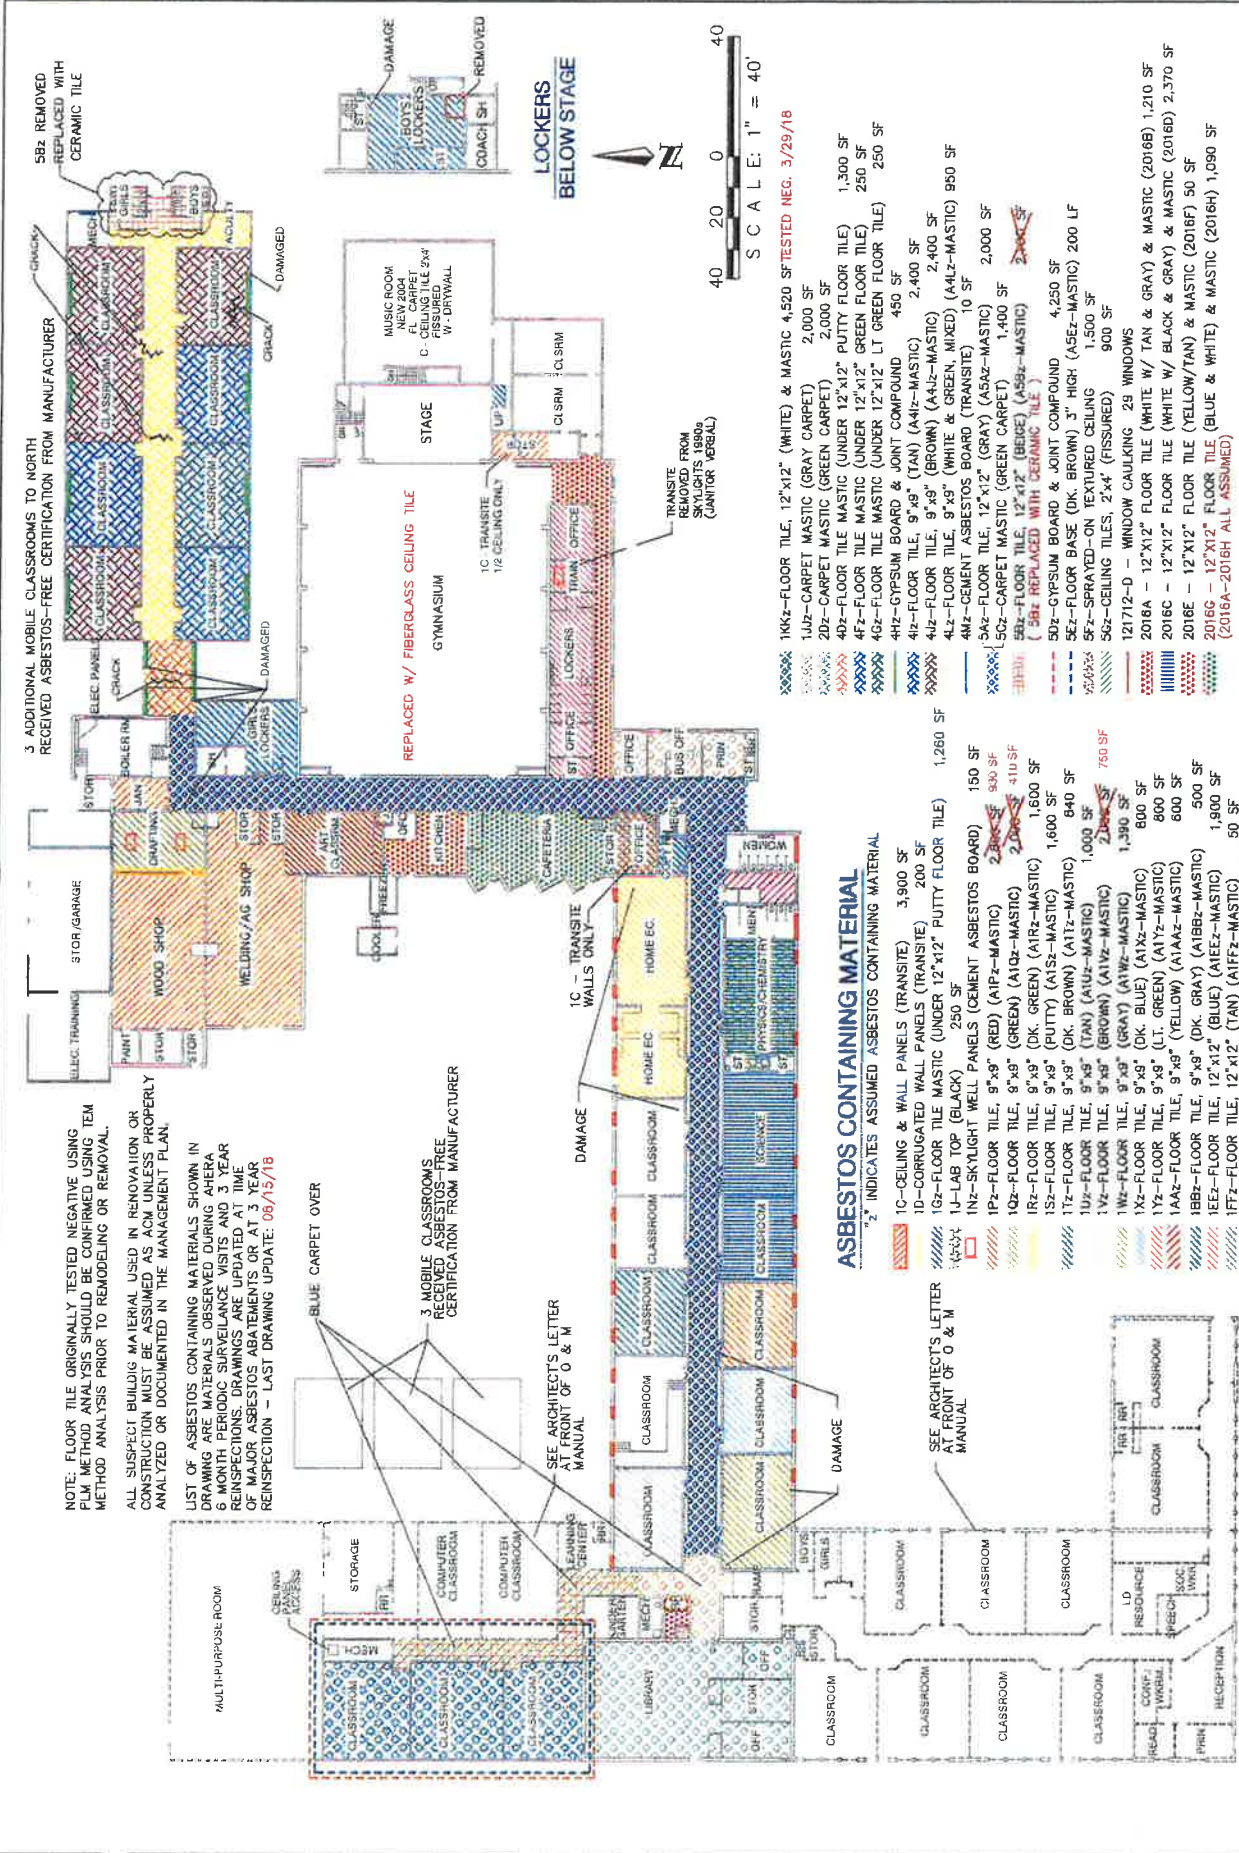
The following floor plan drawing denotes the areas within the Illini West High School that contain assumed asbestos containing material.

As shown on the drawing is a listing of the types of materials and a color-coded hatch pattern that is reflected in the various spaces though out the building. As you can, see the majority of the building's spaces have some form of assumed asbestos containing material.
