Illini
West
High
School
District #307

Referendum
Information

January 2020

Current Facility

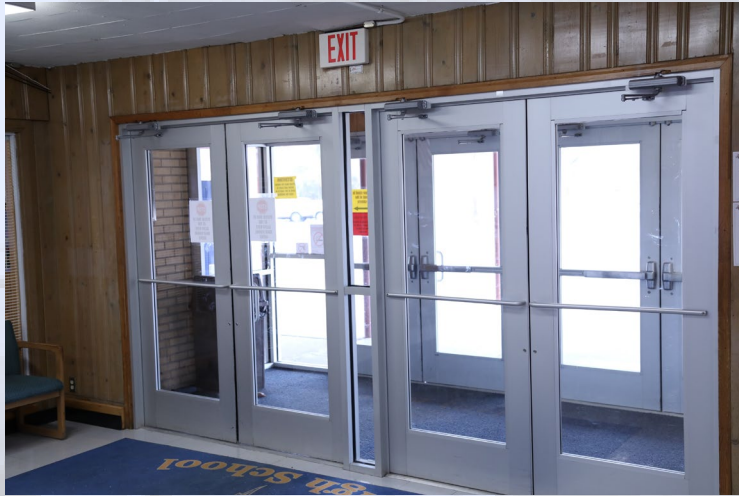
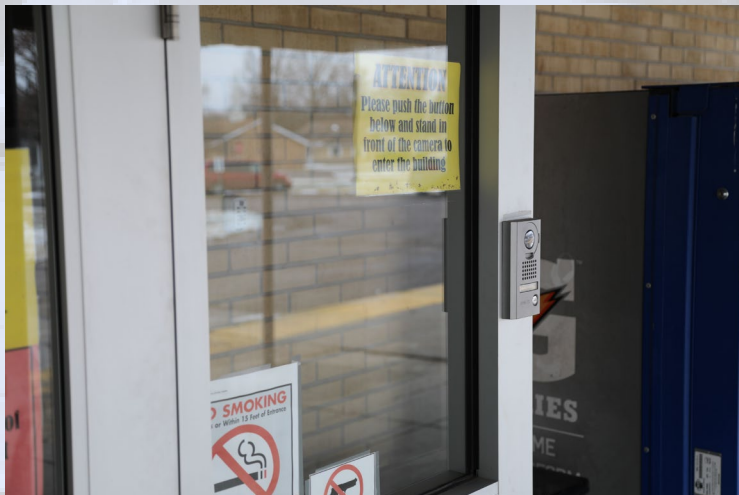
Main Entrance

- Exterior Doors
 - External Camera
 - Automatic Door Locks
- Interior Doors
 - No Containment System
- Russell Recommendation:
 - Install Higher Security Controlled System

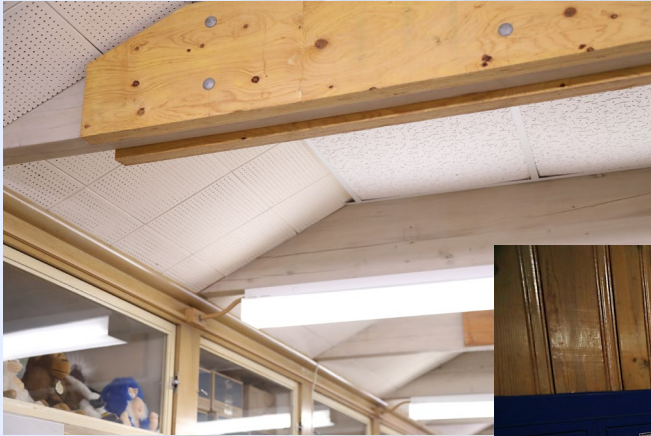
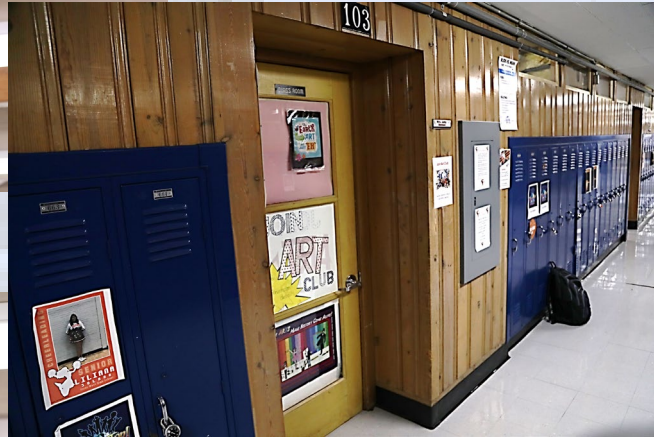
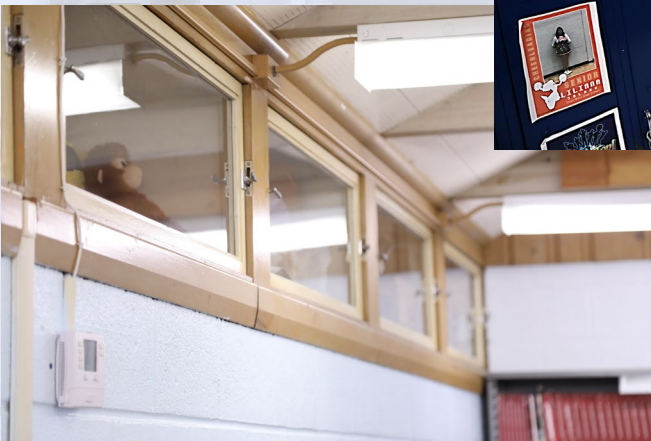
West Wing
Classrooms

- Roof Support Wood Beams
 - Added due to cracking
- Wood Paneling/Not Fire rated walls down hallway
- Active Fire Alarm System
 - No Sprinklers
- Russell Recommendation:
 - Possible Roof Replacement – Structural Engineer?
 - Hallway Renovation for Fire Code

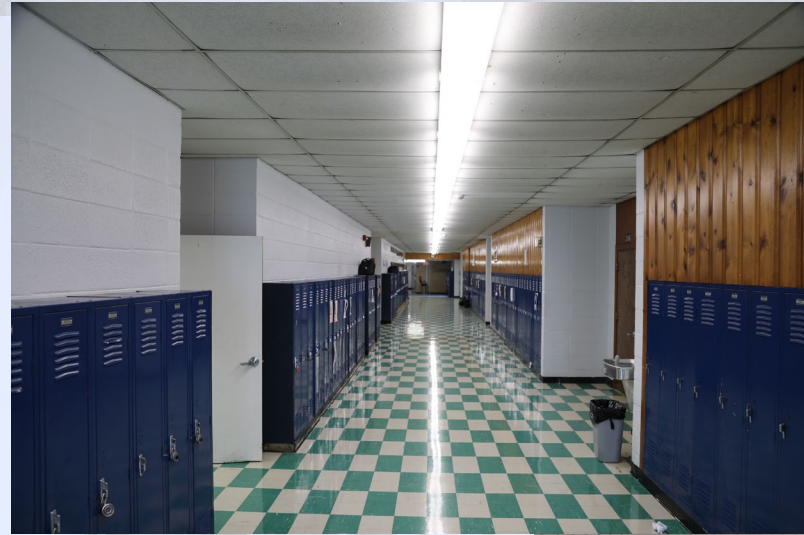
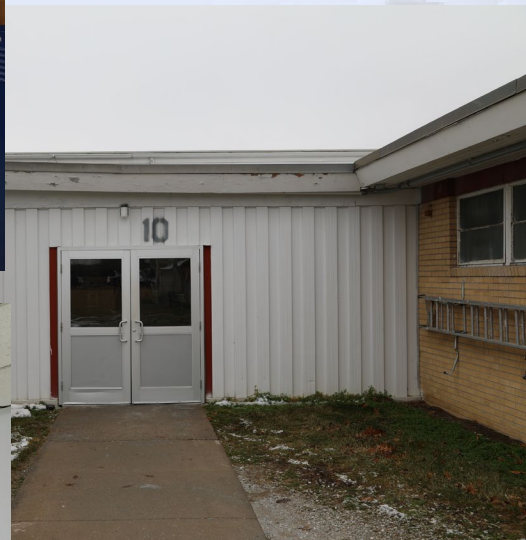
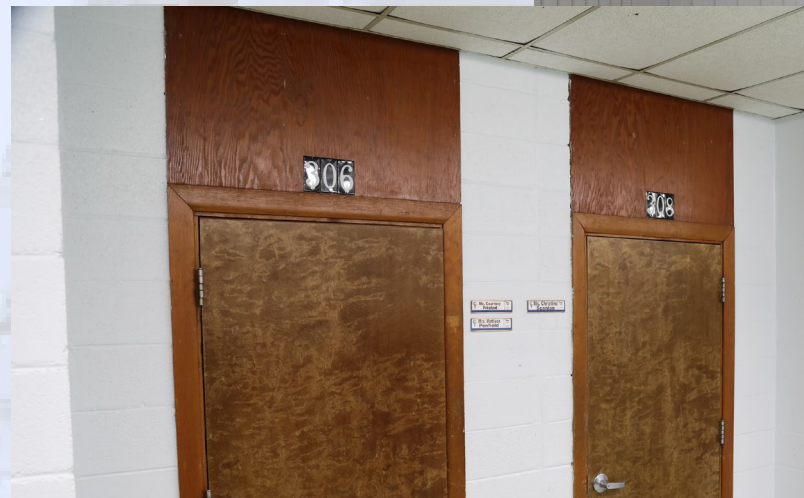
East Wing
Classrooms/Transit
to North Portables

- Wood Doors and Paneling
 - Not fire rated
- Active Fire Alarm System
 - No Sprinklers
- Russell Recommendation:
 - Renovate hallway to code
 - Aluminum outside doors with automated locking

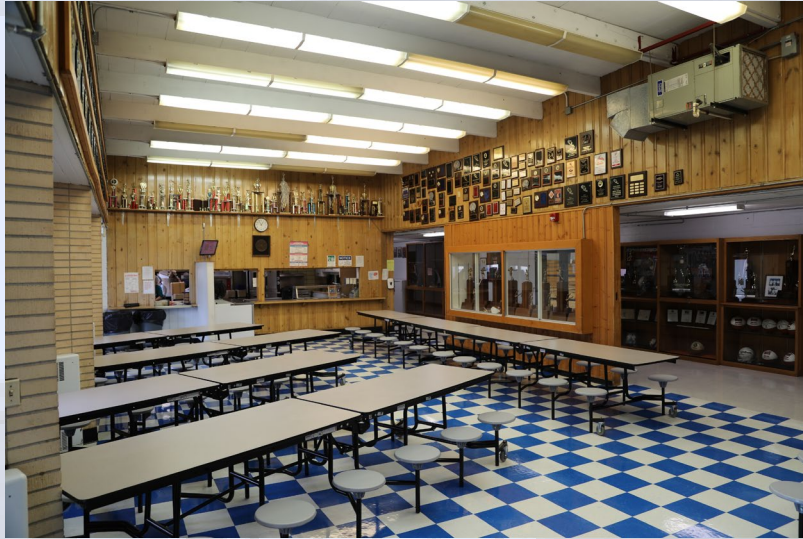
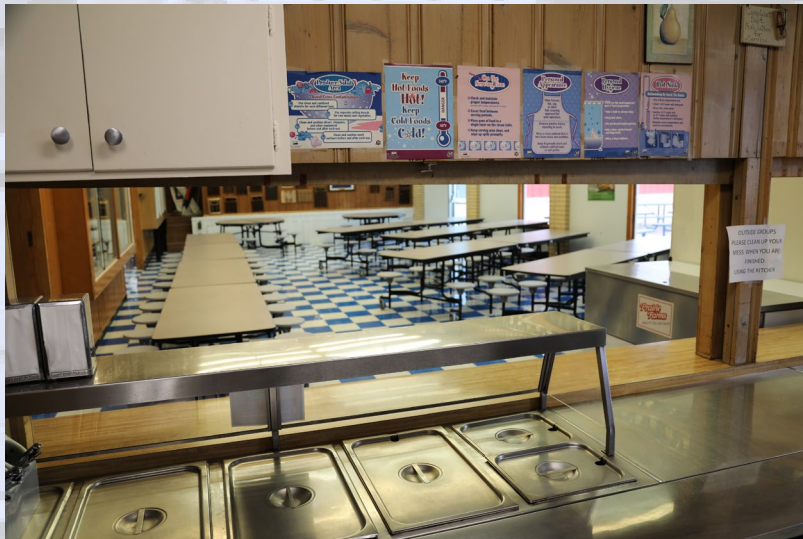
Cafeteria

- Aluminum doors to east – unlocked during day
- Wood paneling not fire rated
- Open to hallway
- Active Fire Alarm System
 - No Sprinklers
- Russell Recommendation:
 - Renovate paneling to code
 - Aluminum doors to corridor for security
 - ADA Accessibility
 - New finishes for all renovations

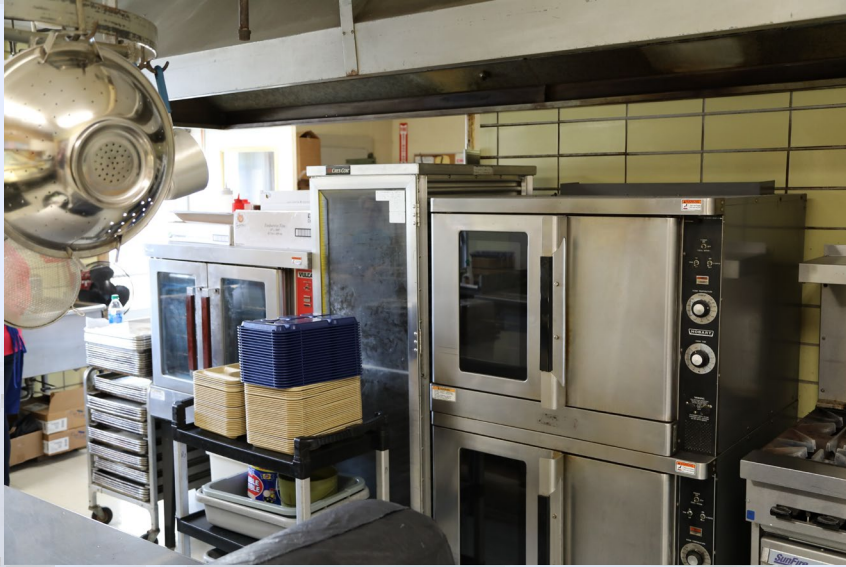
Kitchen

- Assumed to be antiquated equipment, exhaust hood and fire suppression
- Russell Recommendation:
 - Remove fixed kitchen systems
 - Install code rated hood, make up air, fire suppression
 - Replace existing equipment

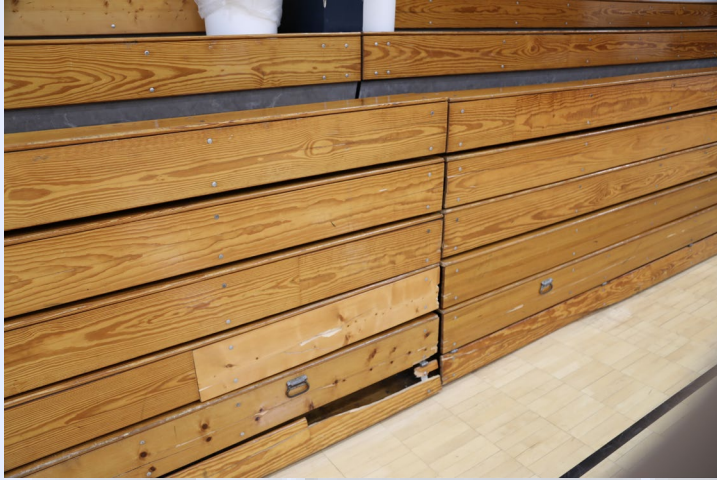
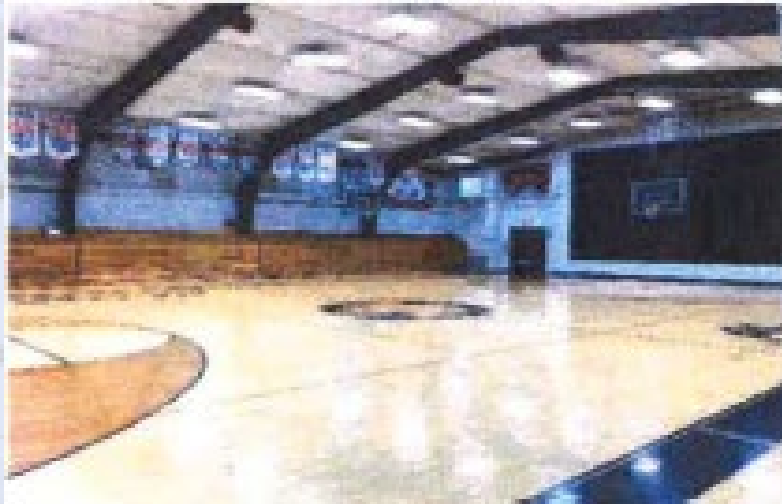
Gymnasium

- Assumed to be antiquated equipment including bleachers
- Wood paneling not fire rated
- Fire alarm system in place, no sprinklers
- Russell Recommendation:
 - Replace bleachers
 - Replace door systems with fire rated
 - New finishes for all renovations

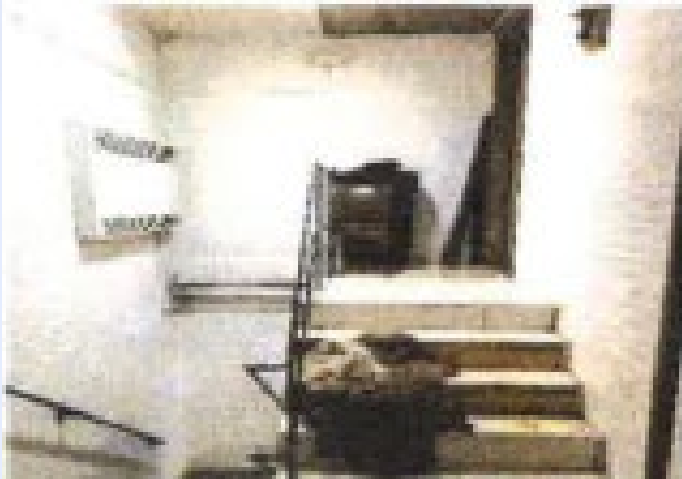
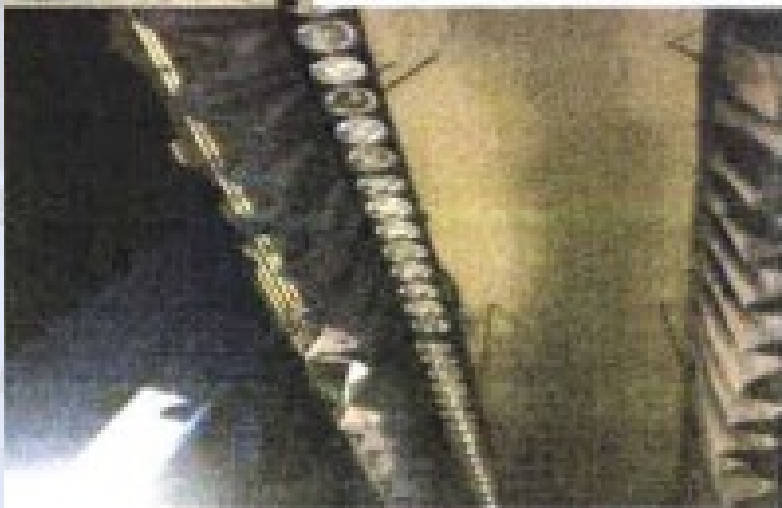
Stage/Music Room

- Not meeting ADA accessibility
 - Does not meet current fire code
 - Fixed lighting antiquated
 - Exposed wood elements not fire rated
-
- Russell Recommendation
 - Install ADA certified means to stage
 - Replace stage lighting and rigging
 - Replace opening curtains
 - Remove all non fire rated wood and replace with fire rated

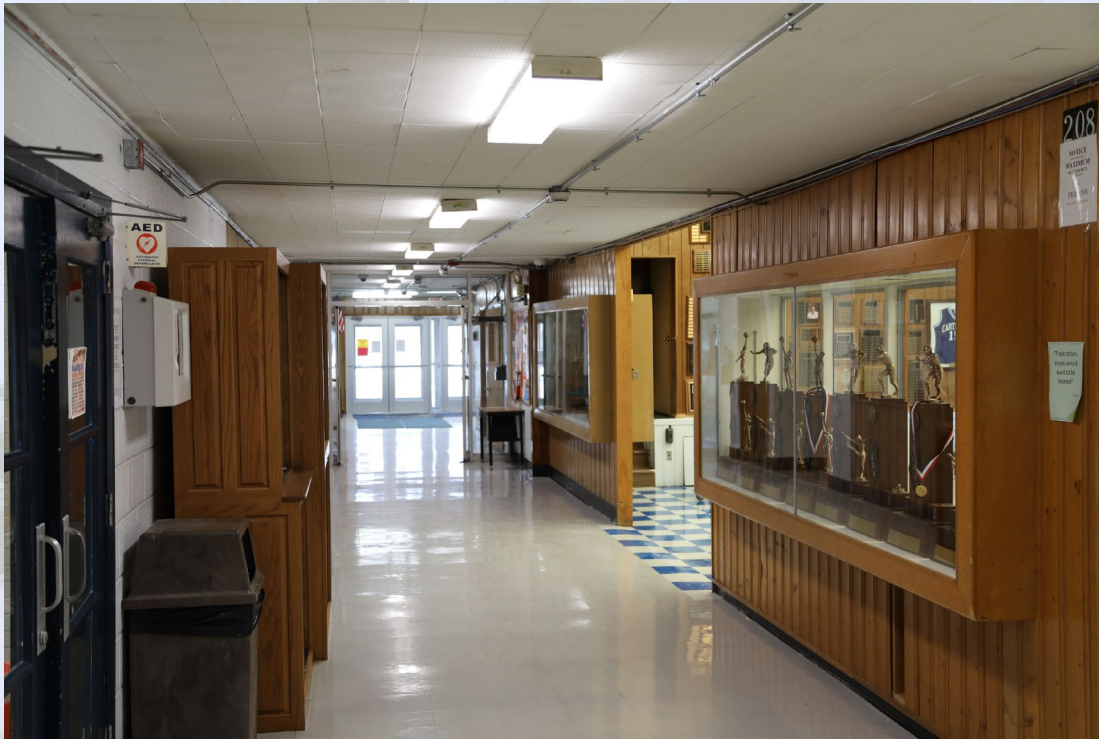
Main Corridor/South
West Wing

- Wood Doors and Paneling
 - Not fire rated
- Active Fire Alarm System
 - No Sprinklers
- Russell Recommendation:
 - Remove wood paneling and doors, replace with fire rated
 - Structural repairs and reinforcements
 - New finishes for all renovations

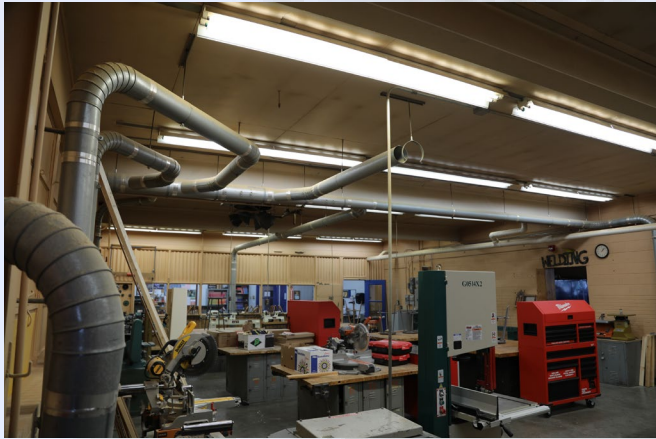
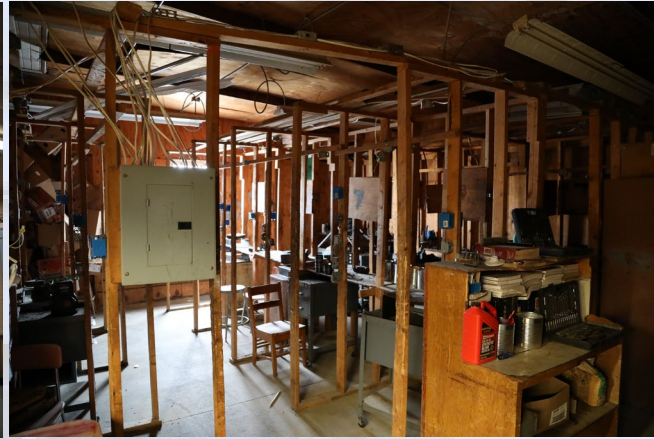
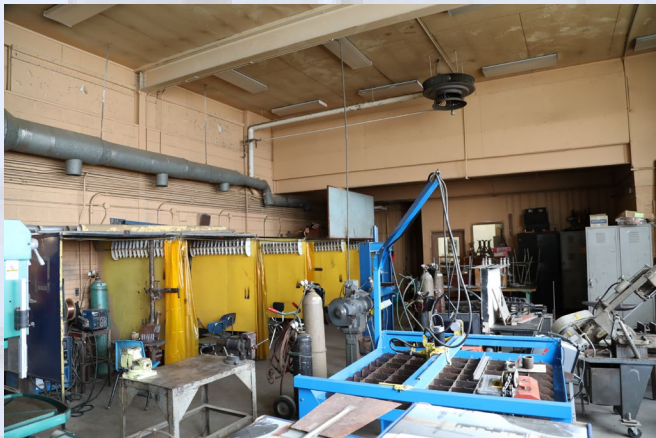
Tech Shop Areas

- Wood paneling not fire rated
- Active Fire Alarm System
 - No Sprinklers
- Plumbing not to code
- Numerous open areas non fire rated sheeting
- Russell Recommendation:
 - Replace all wall and ceiling surfaces
 - Fire rated systems throughout
 - Renovation of bathroom
 - Replace collection systems

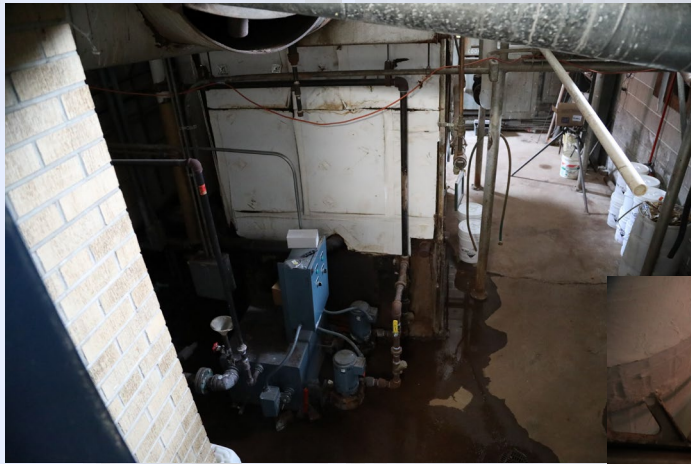
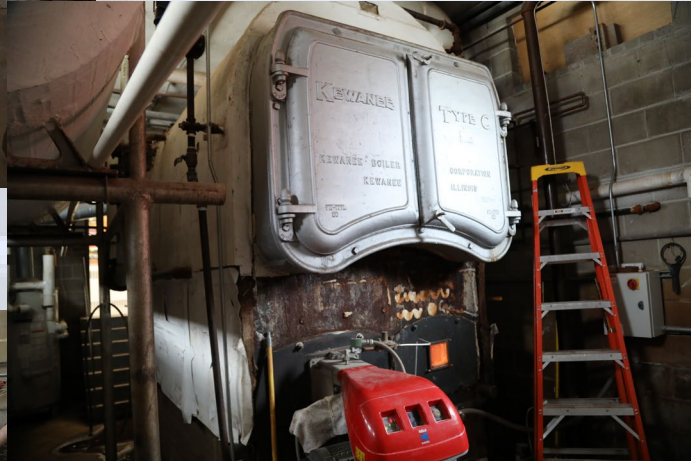
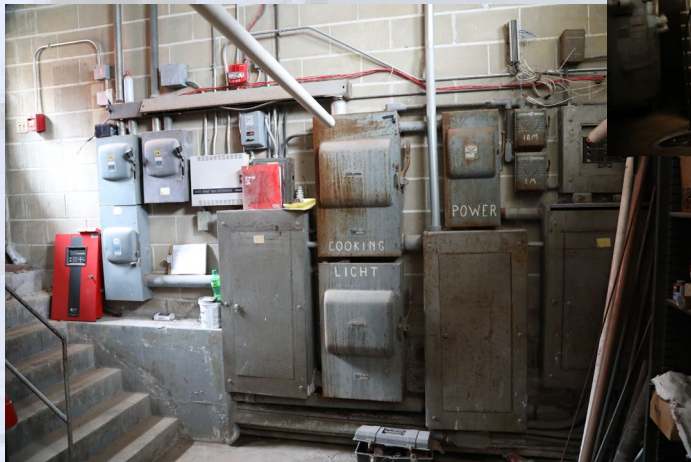
Boiler Room/Building Systems

- Assumed to be antiquated equipment
- Boiler likely past useful life
- Entire HVAC system likely antiquated
- Electrical system past useful life
- Russell Recommendation:
 - Complete removal of all old HVAC and new systems installed
 - Complete removal of old electrical and replacement
 - Upgrade water, fire suppression, gas, electrical

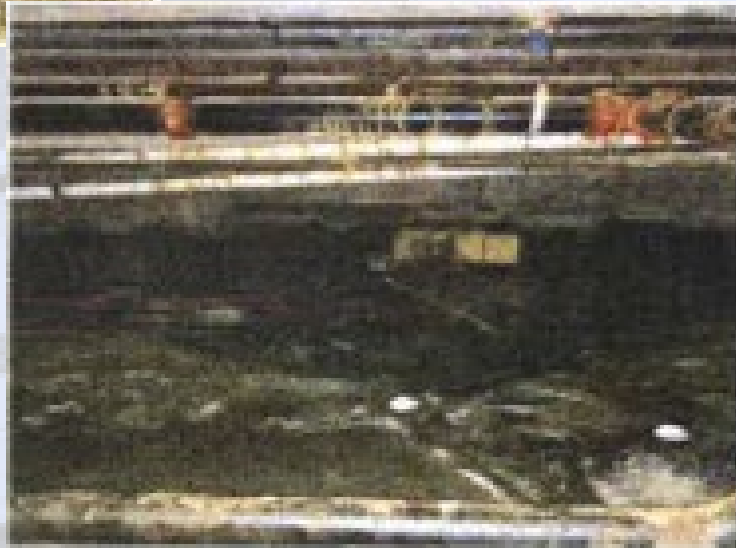
Building Tunnel

- Limited moisture control
- HVAC and mechanical items assumed end of life
- Russell Recommendation:
 - Remove debris, mess from tunnels
 - Install moisture control
 - Install service lighting
 - Secure entrance to tunnels

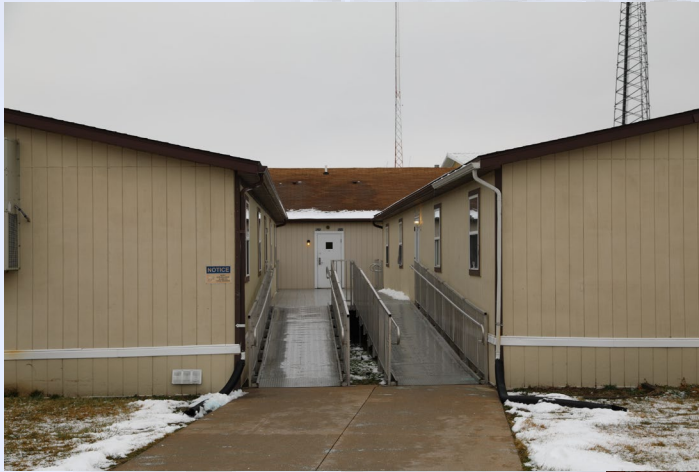
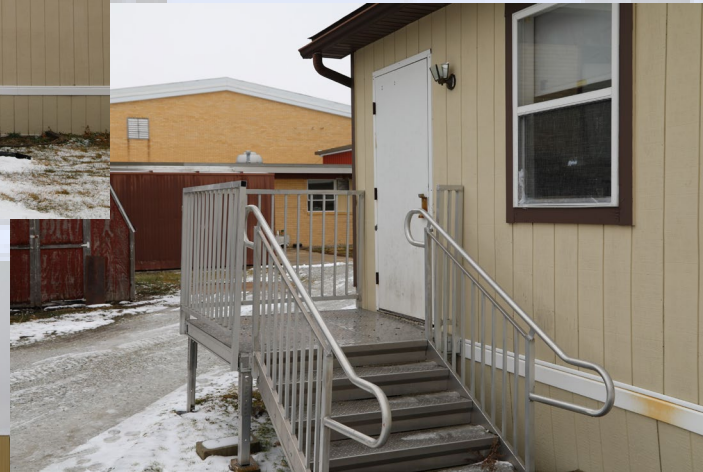
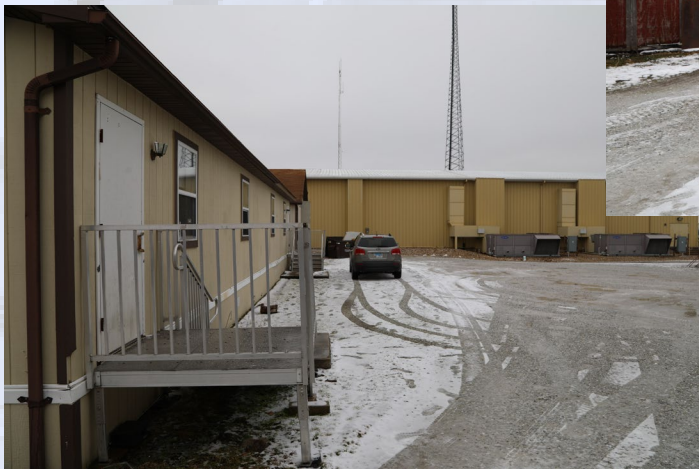
West Portable
Classrooms

- Assumed to be past useful life
- Railings, flooring, metal ramp all assumed need to be replaced
- Not at code for temporary building
- Russell Recommendation:
 - Remove portable/temporary structure
 - Build new permanent feature connected to school

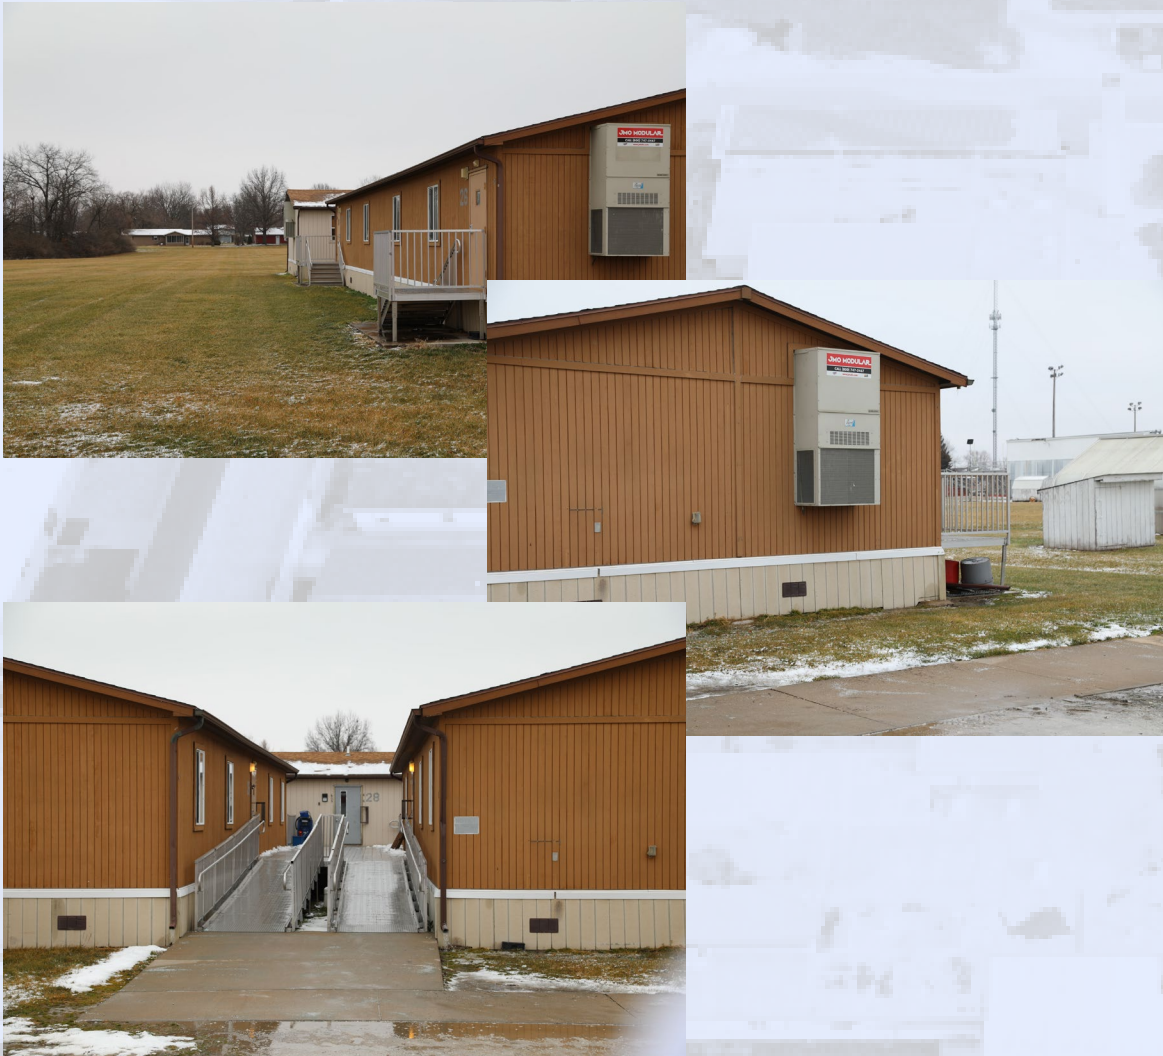
North Portable
Classrooms

- Assumed to be past useful life
- Railings, flooring, metal ramp all assumed need to be replaced
- Not at code for temporary building

- Russell Recommendation:
 - Remove portable/temporary structure
 - Build new permanent feature connected to school

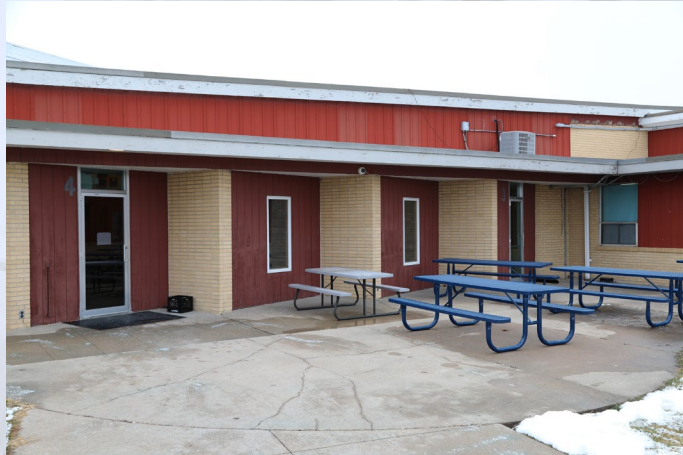
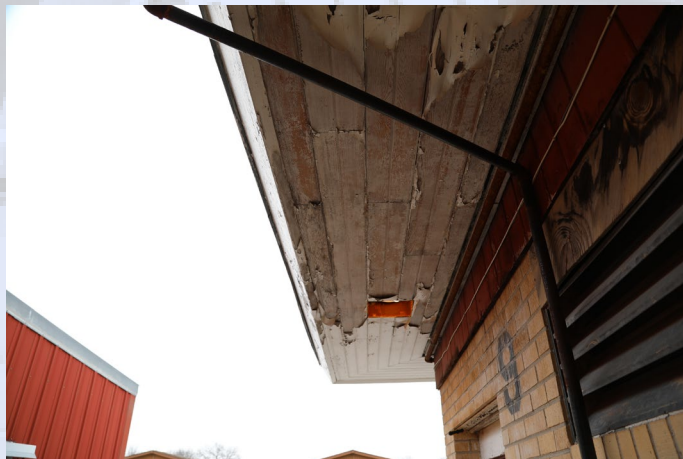
Building Exterior

- Soffit is old and needs replaced
 - Water remediation issues
 - Window frames antiquated
 - ADA accessibility issues
-
- Russell Recommendation:
 - New windows
 - Clean, tuck, repair outside veneer
 - Replace pavement
 - Replace sidewalks for ADA code
