Illini
West
High
School
District #307

Referendum
Information

January 2020

Current Facility

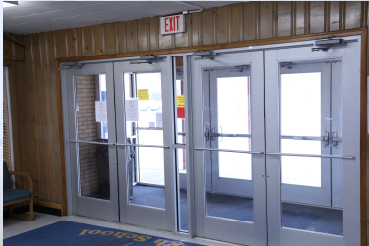
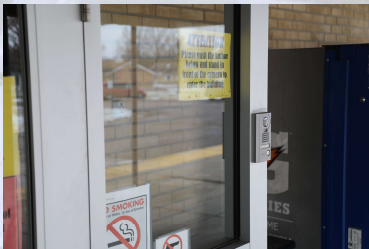
Main Entrance

- Exterior Doors
 - External Camera
 - Automatic Door Locks
- Interior Doors
 - No Containment System
- Russell Recommendation:
 - Install Higher Security Controlled System

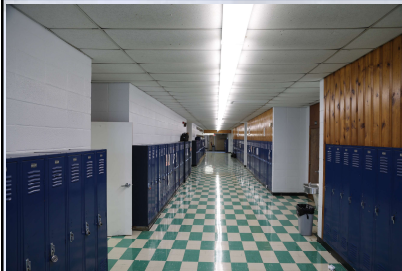
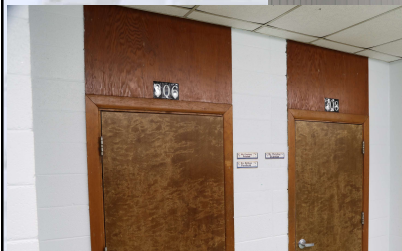
East Wing
Classrooms/Transit
to North Portables

- Wood Doors and Paneling
 - Not fire rated
- Active Fire Alarm System
 - No Sprinklers
- Russell Recommendation:
 - Renovate hallway to code
 - Aluminum outside doors with automated locking

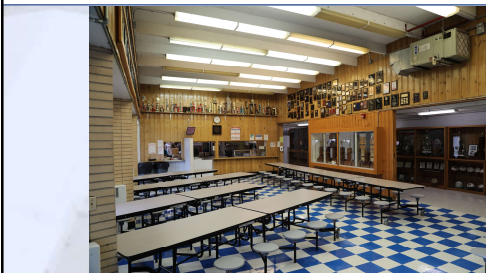
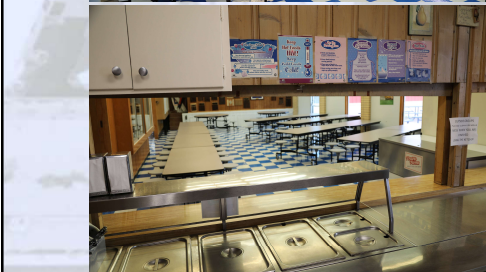
Cafeteria

- Aluminum doors to east – unlocked during day
- Wood paneling not fire rated
- Open to hallway
- Active Fire Alarm System
 - No Sprinklers
- Russell Recommendation:
 - Renovate paneling to code
 - Aluminum doors to corridor for security
 - ADA Accessibility
 - New finishes for all renovations

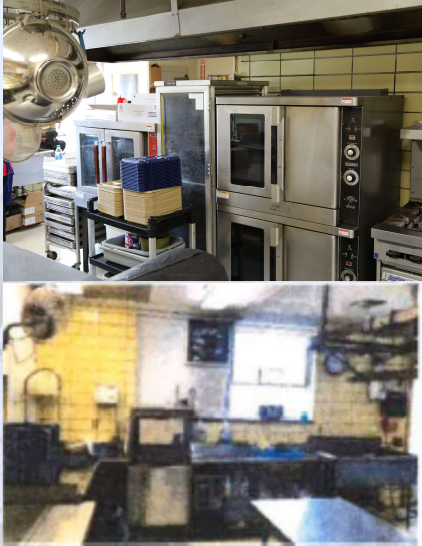
Kitchen

- Assumed to be antiquated equipment, exhaust hood and fire suppression
- Russell Recommendation:
 - Remove fixed kitchen systems
 - Install code rated hood, make up air, fire suppression
 - Replace existing equipment

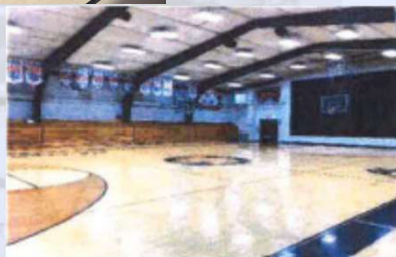
Gymnasium

- Assumed to be antiquated equipment including bleachers
- Wood paneling not fire rated
- Fire alarm system in place, no sprinklers
- Russell Recommendation:
 - Replace bleachers
 - Replace door systems with fire rated
 - New finishes for all renovations

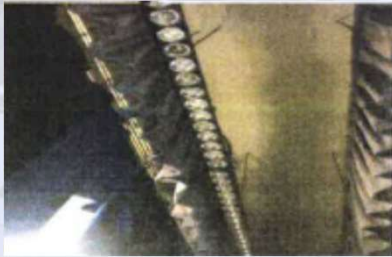
Stage/Music Room

- Not meeting ADA accessibility
- Does not meet current fire code
- Fixed lighting antiquated
- Exposed wood elements not fire rated
- Russell Recommendation
 - Install ADA certified means to stage
 - Replace stage lighting and rigging
 - Replace opening curtains
 - Remove all non fire rated wood and replace with fire rated

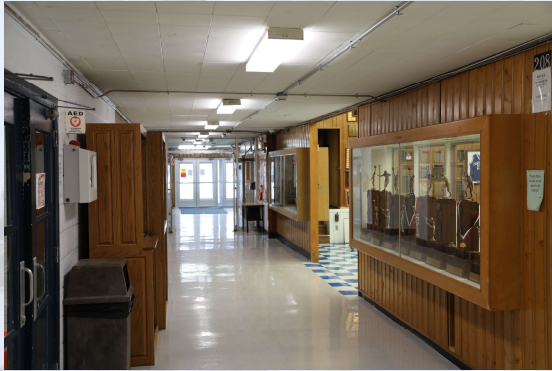
Main Corridor/South
West Wing

- Wood Doors and Paneling
 - Not fire rated
- Active Fire Alarm System
 - No Sprinklers
- Russell Recommendation:
 - Remove wood paneling and doors, replace with fire rated
 - Structural repairs and reinforcements
 - New finishes for all renovations

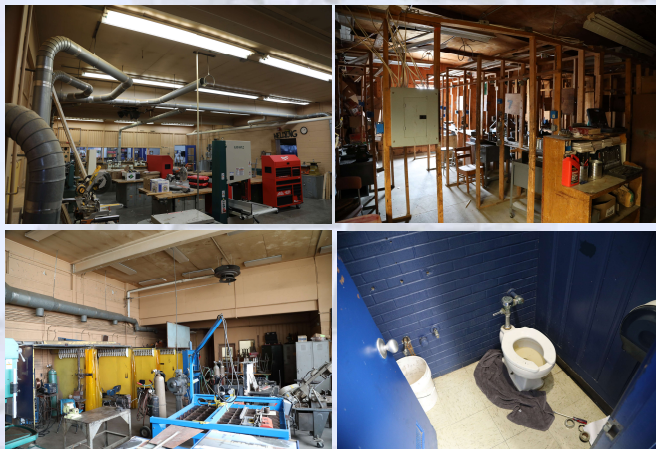
Tech Shop Areas

- Wood paneling not fire rated
- Active Fire Alarm System
 - No Sprinklers
- Plumbing not to code
- Numerous open areas non fire rated sheeting
- Russell Recommendation:
 - Replace all wall and ceiling surfaces
 - Fire rated systems throughout
 - Renovation of bathroom
 - Replace collection systems

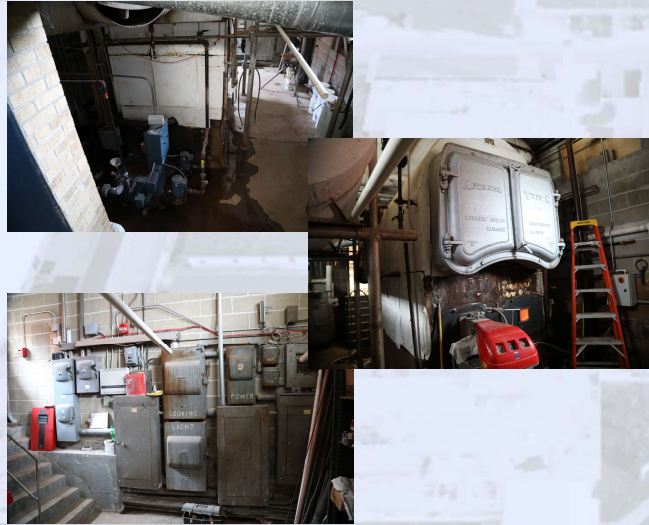
Boiler Room/Building Systems

- Assumed to be antiquated equipment
- Boiler likely past useful life
- Entire HVAC system likely antiquated
- Electrical system past useful life
- Russell Recommendation:
 - Complete removal of all old HVAC and new systems installed
 - Complete removal of old electrical and replacement
 - Upgrade water, fire suppression, gas, electrical

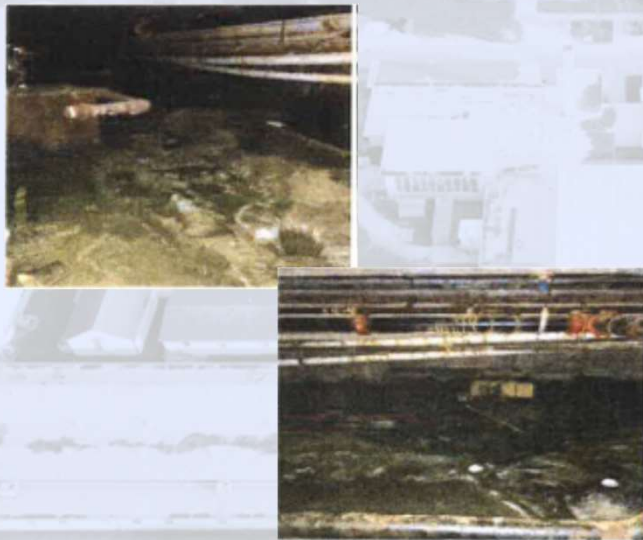
Building Tunnel

- Limited moisture control
- HVAC and mechanical items assumed end of life
- Russell Recommendation:
 - Remove debris, mess from tunnels
 - Install moisture control
 - Install service lighting
 - Secure entrance to tunnels

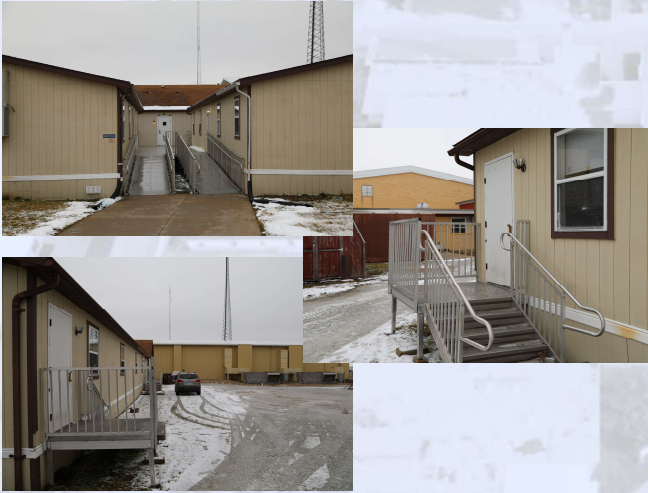
West Portable Classrooms

- Assumed to be past useful life
- Railings, flooring, metal ramp all assumed need to be replaced
- Not at code for temporary building
- Russell Recommendation:
 - Remove portable/temporary structure
 - Build new permanent feature connected to school

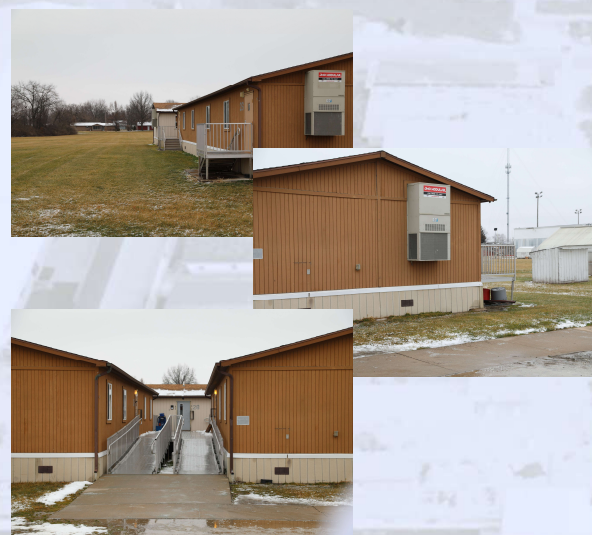
North Portable Classrooms

- Assumed to be past useful life
- Railings, flooring, metal ramp all assumed need to be replaced
- Not at code for temporary building
- Russell Recommendation:
 - Remove portable/temporary structure
 - Build new permanent feature connected to school
